Restoration of the Piazza Fountain, Liverpool

Merseyside Civic Society

Restoration of the Piazza Fountain, Drury Lane, Liverpool

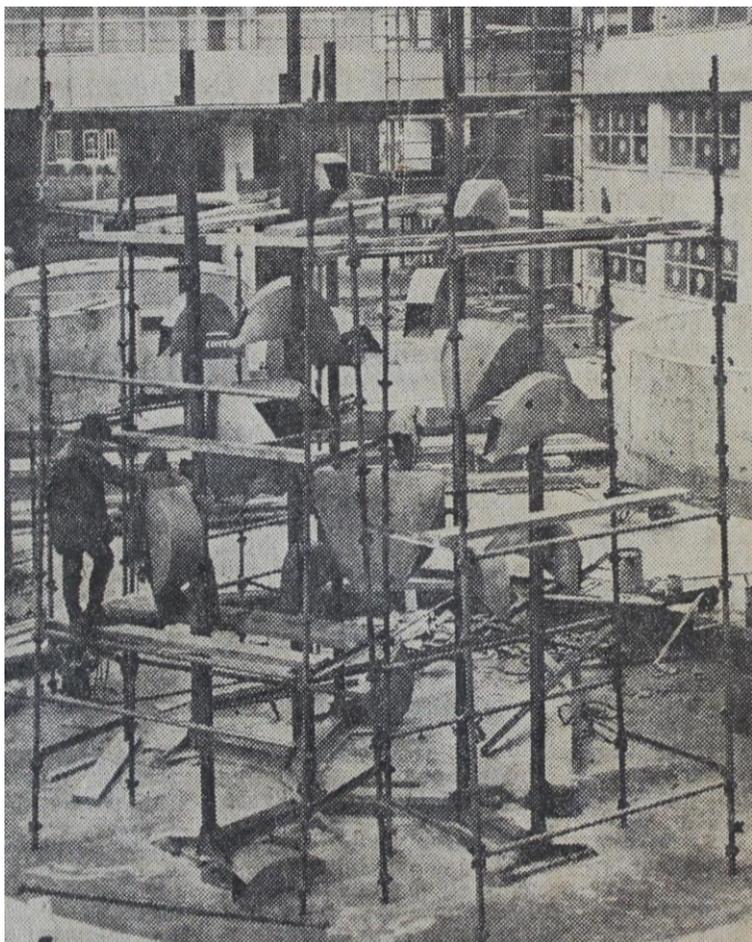
Installation of Fountain, 1966/67
Showing original metal manifold base

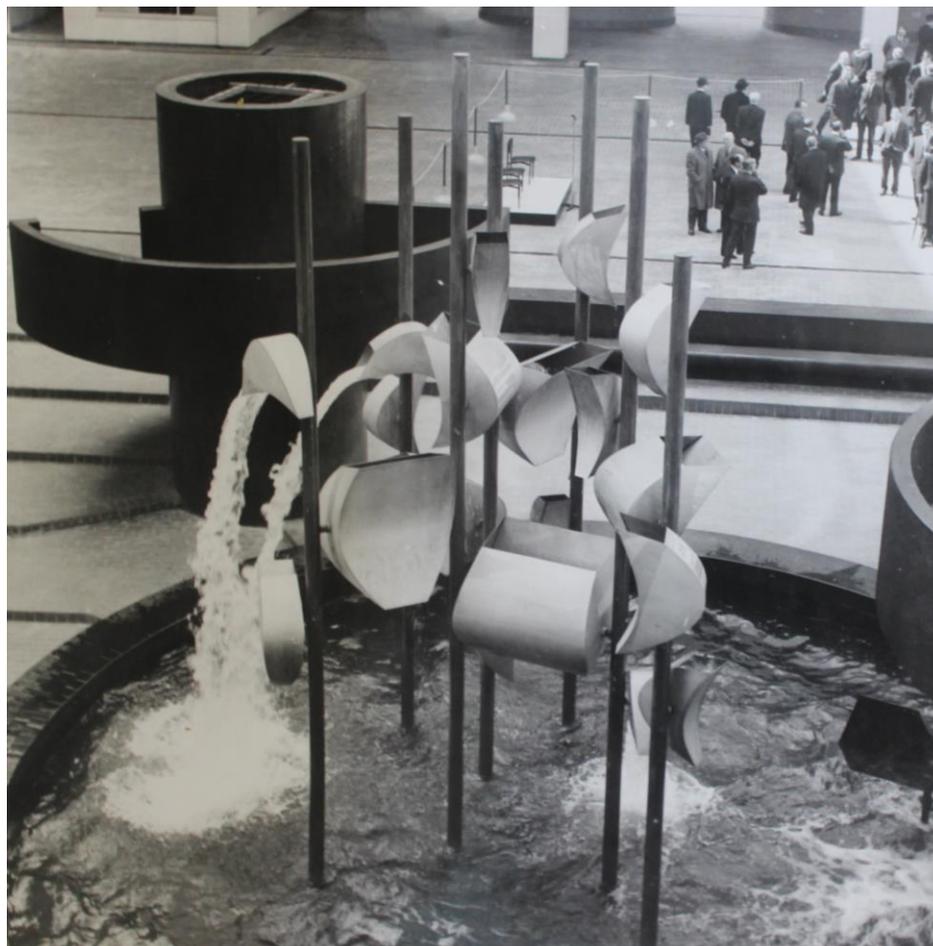
Opening, 2nd May 1967: Fountain rises out of water
Base fully concealed under waves & white water in pool

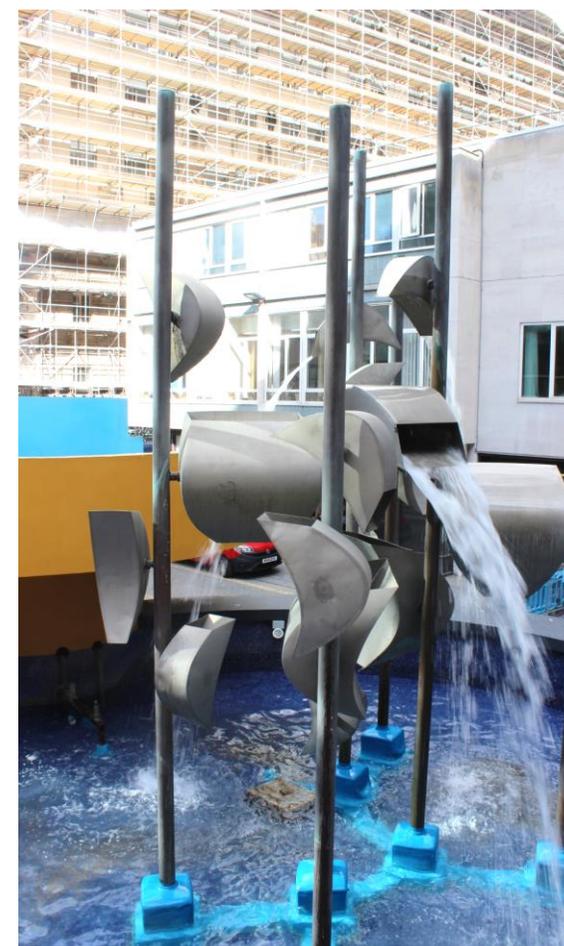
Current manifold base encased & very prominent

- ❑ Original manifold base strengthened by encasing in concrete and fountain height reduced by some 400mm (possibly prior to 1997)
- ❑ New bright blue waterproof covering applied to concrete (circa late 2017 or early 2018 - recently re-painted)

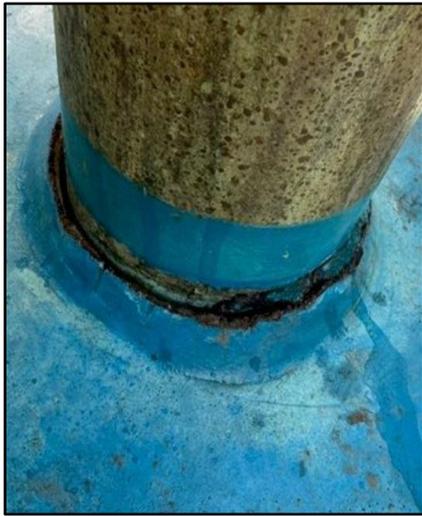
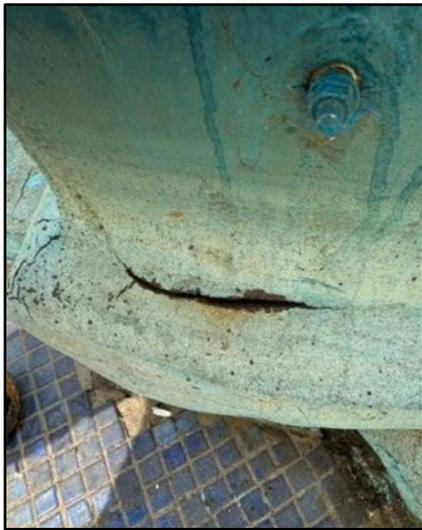
Cracks in existing base
(recently patched up and repainted)

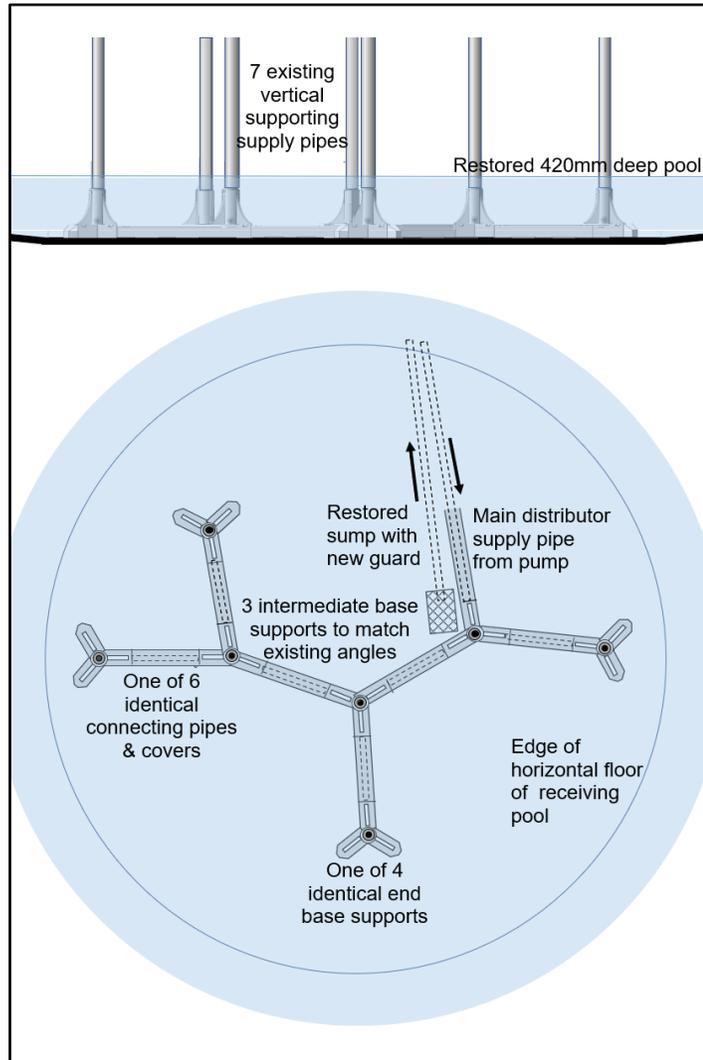
Overall plan & elevation of new manifold
Fabricated in 7 base and 6 connecting parts all dismantlable for any future maintenance

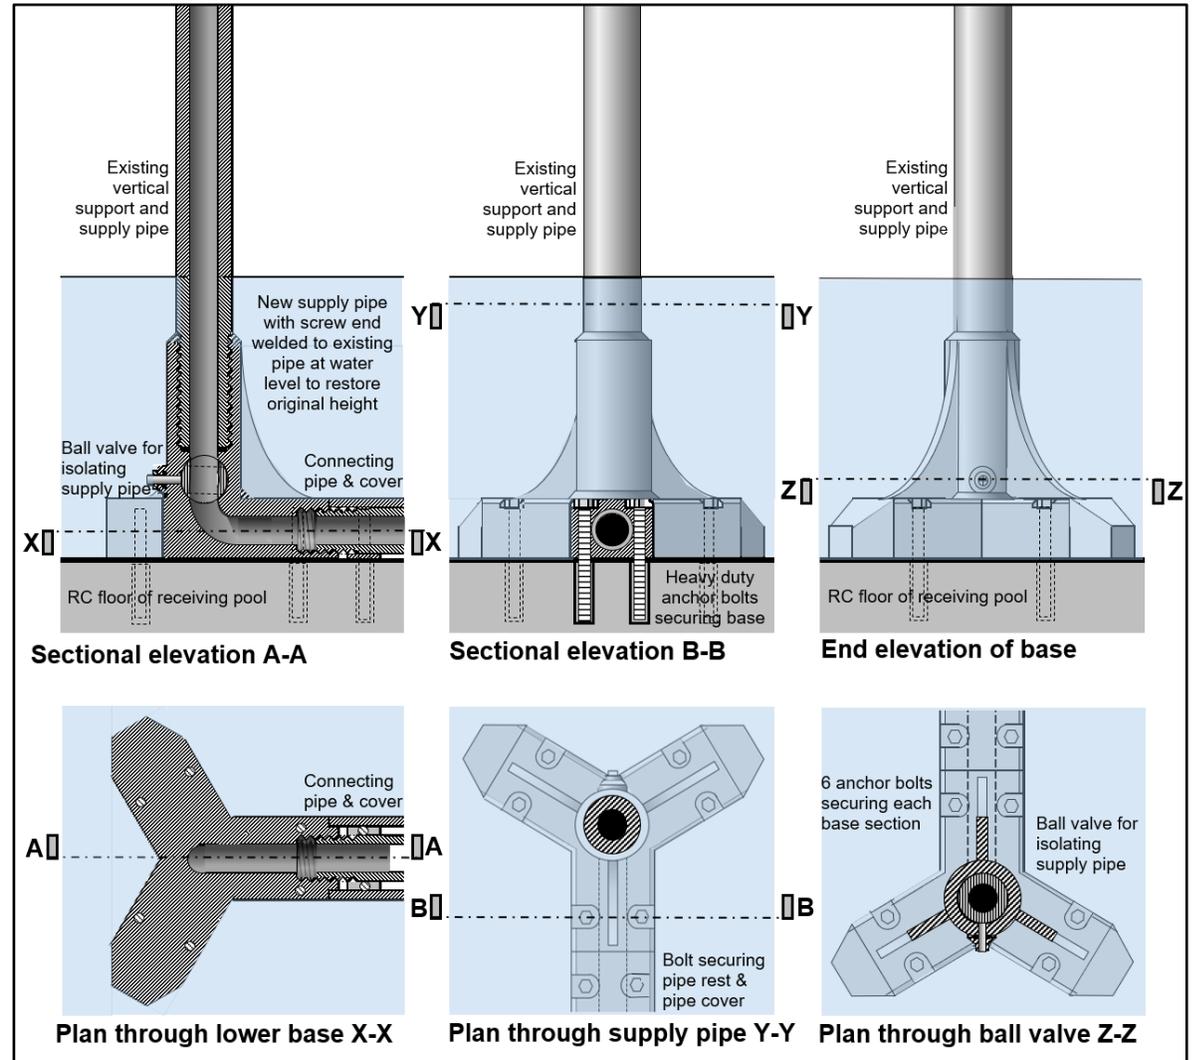
Sections, elevations and plans of a standard end base section
New supply pipes welded to bottom of existing 7 verticals at water level and screwed into bases to restore original height of fountain

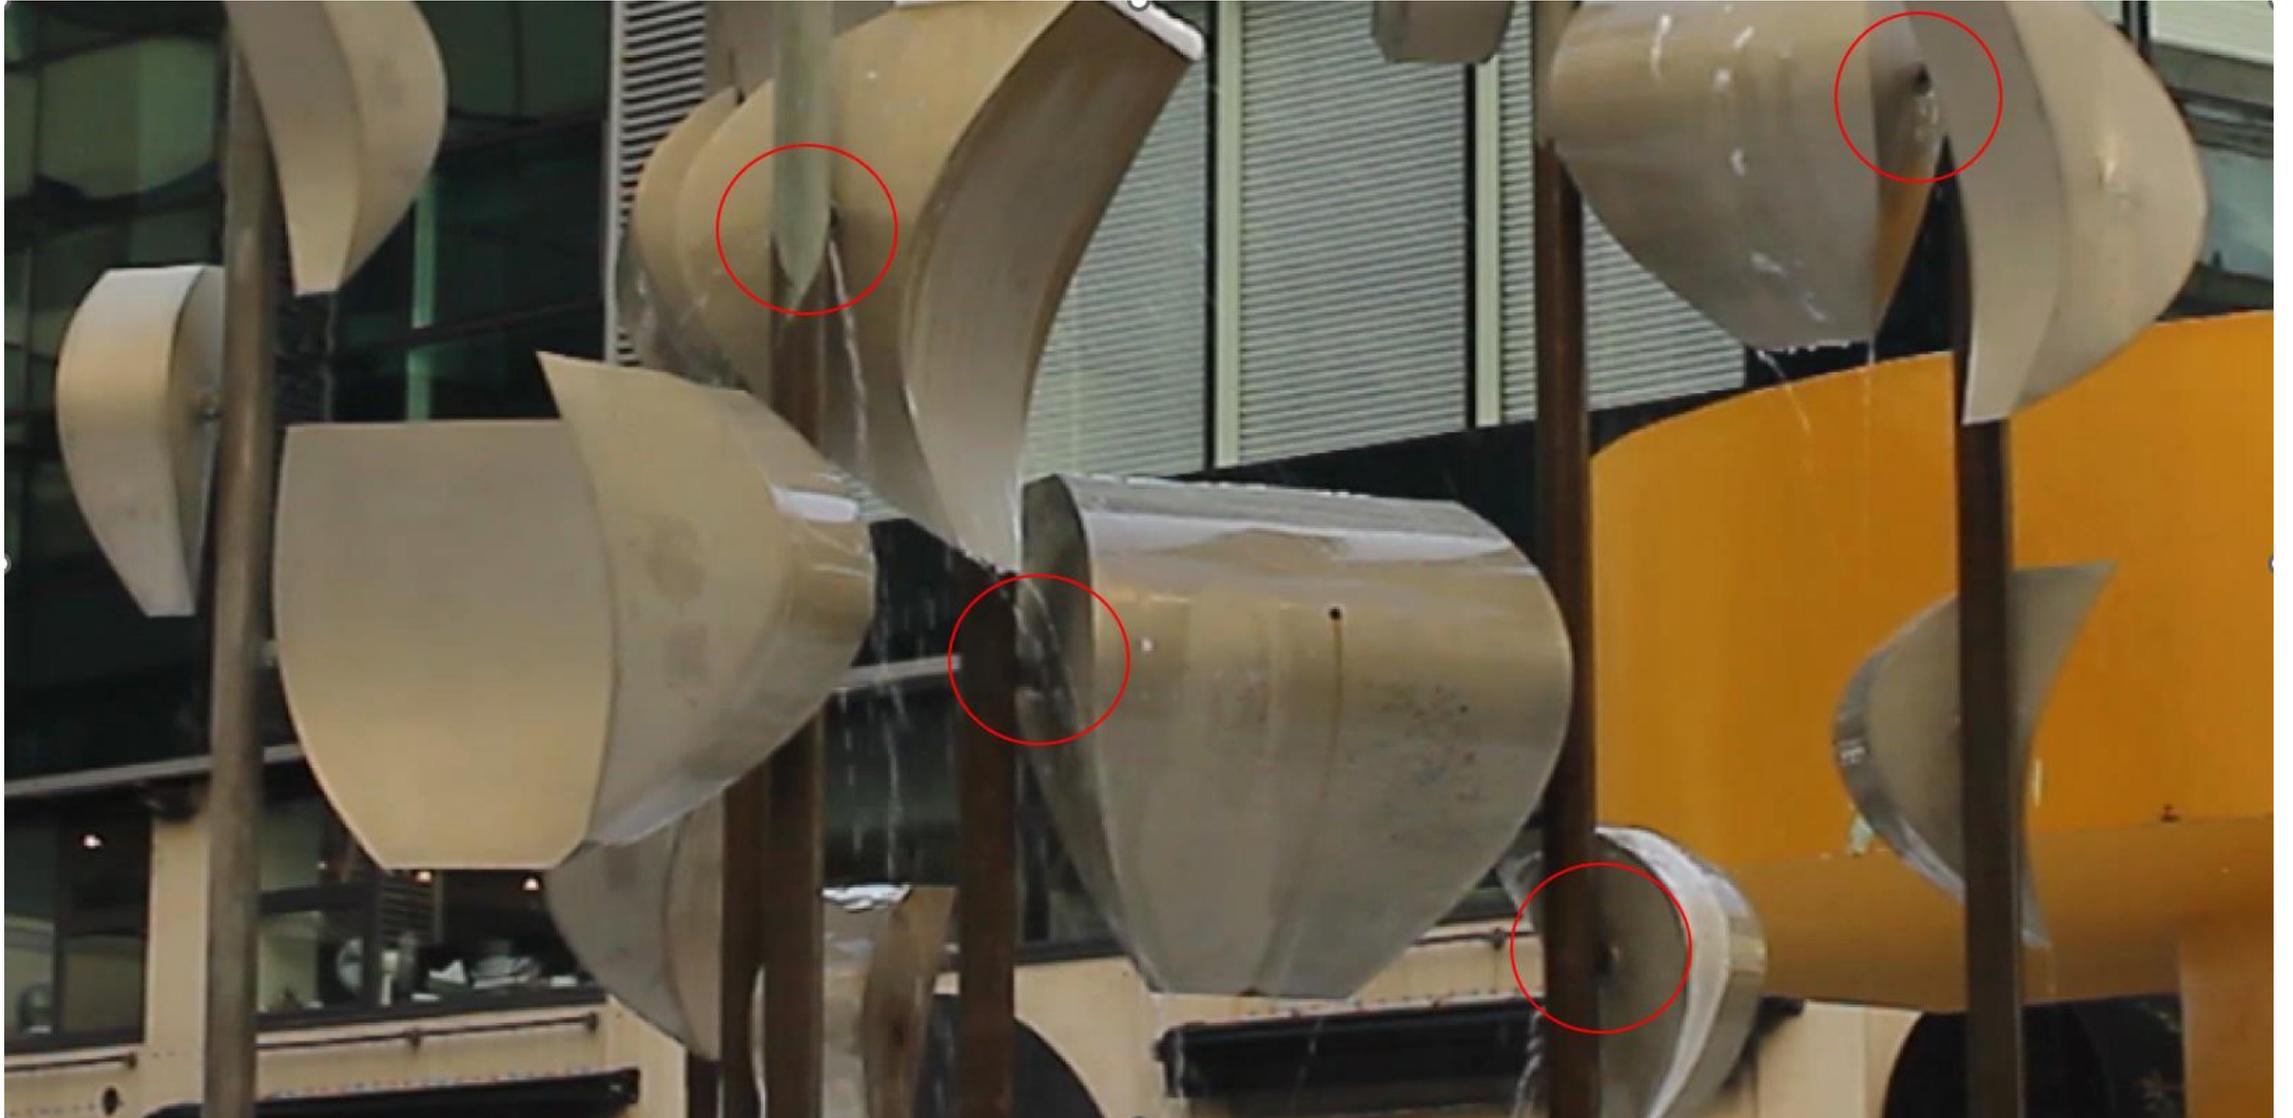
Photograph of the Leaking Piazza 'Bucket' Fountain (Buckets leak once filling water reaches central axle/supply pipe)

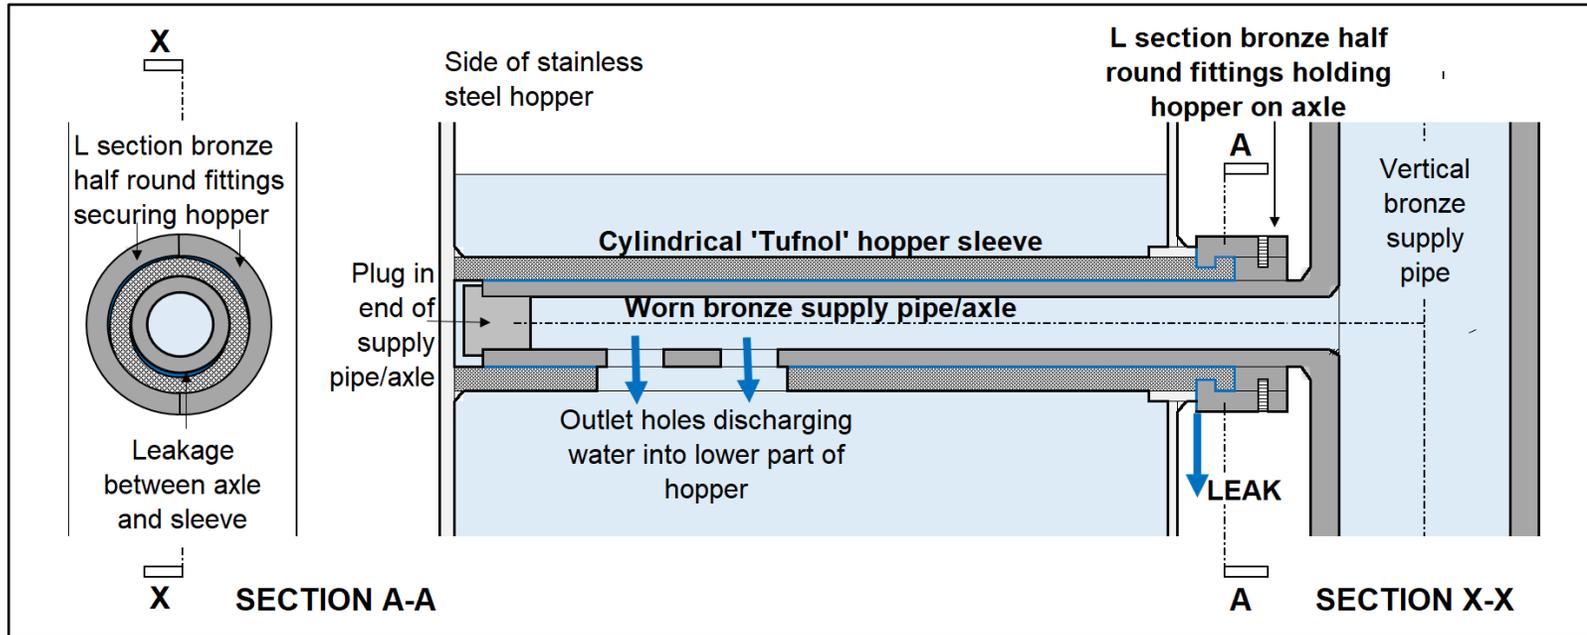
Sections through the existing bearings of one of the 14 smaller cantilevered hopper/ buckets.

SECTION A-A through existing L-section bronze half round fitting

SECTION X-X through existing revolving hopper and fixed vertical & horizontal supply pipes

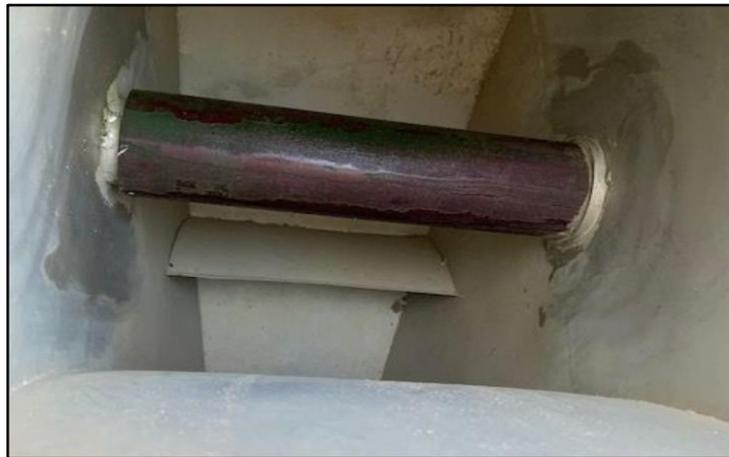
Cylindrical 'Tufnol' hopper sleeve through centre of smaller hopper/bucket

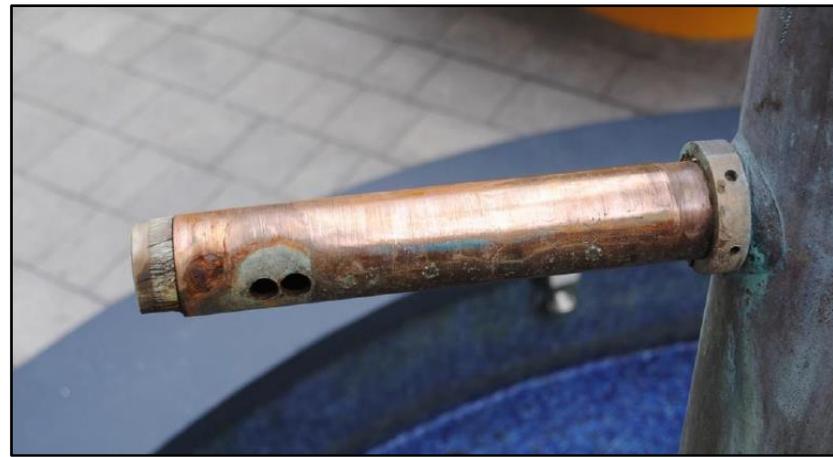
Worn bronze supply pipe/axle causing leaks between axle and 'Tufnol' sleeve

- 1) Replace all worn bronze axles/supply pipes** (with more wear/corrosion resistant cupronickel or aluminium nickel bronze pipes)
- 2) Weld new stainless-steel housing to side of hoppers/buckets** (to replace projecting TUFNOL sleeve & existing fittings)
- 3) Pressure fit new radial shaft seal in housing** (flexible lip of seal help tight against new axles by water pressure)
- 4) Secure seal in place by new stainless-steel clamping plate** (Remove to renew seal as required)

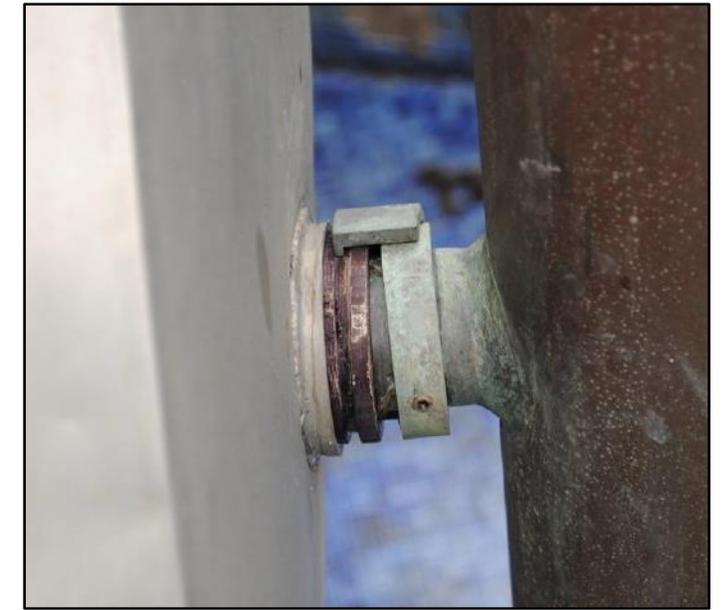
Half round fitting removed to show area from which 'buckets' leak

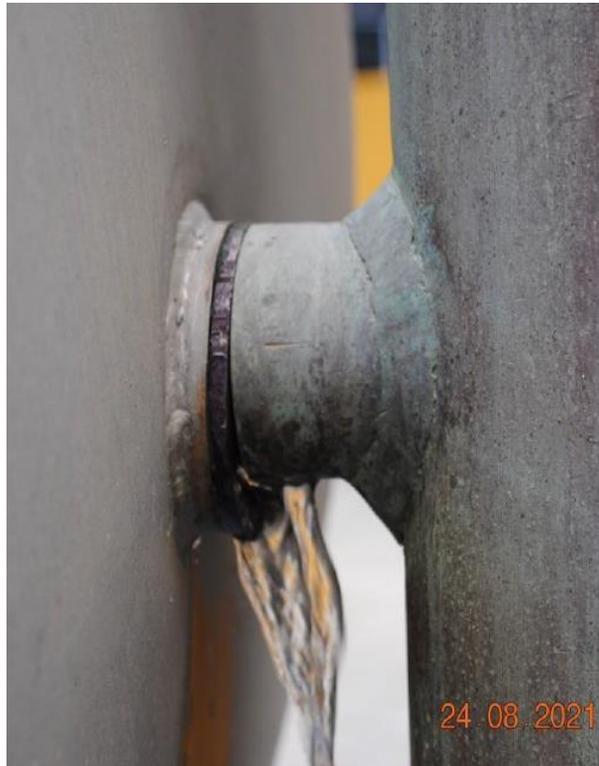
Drop & leak from larger 'bucket'
Cause as for smaller buckets

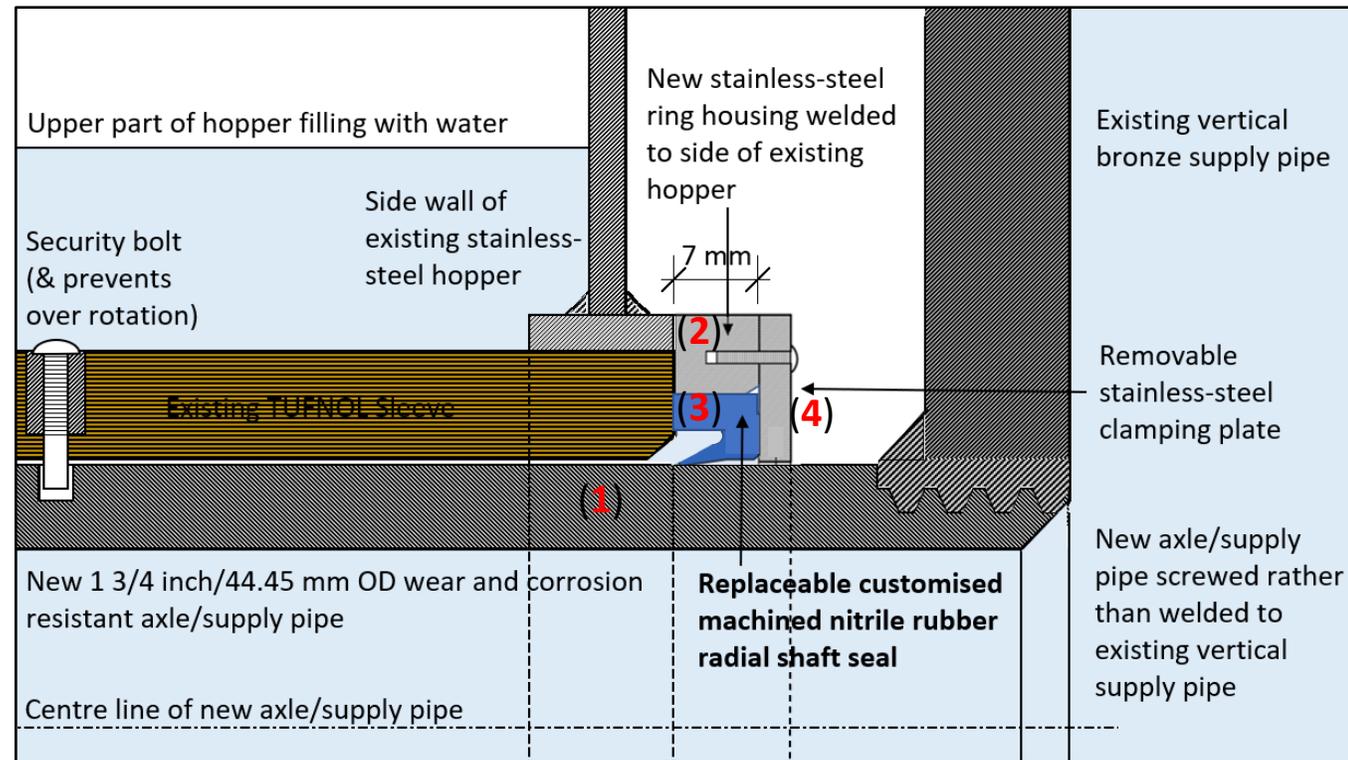
Proposed customised seal in new stainless-steel ring housing
welded to side of existing hoppers & secured by new clamping plate

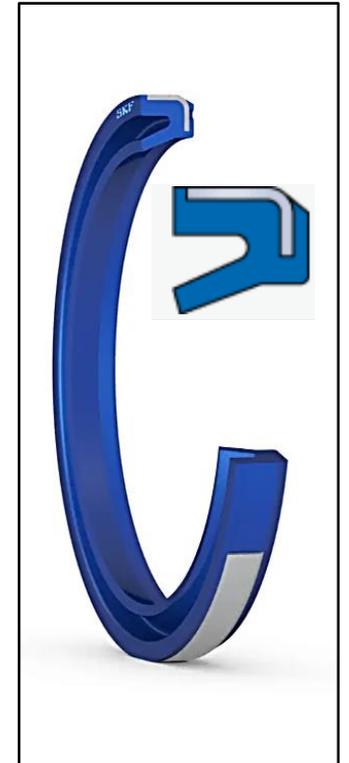
Similar MCW wiper seal

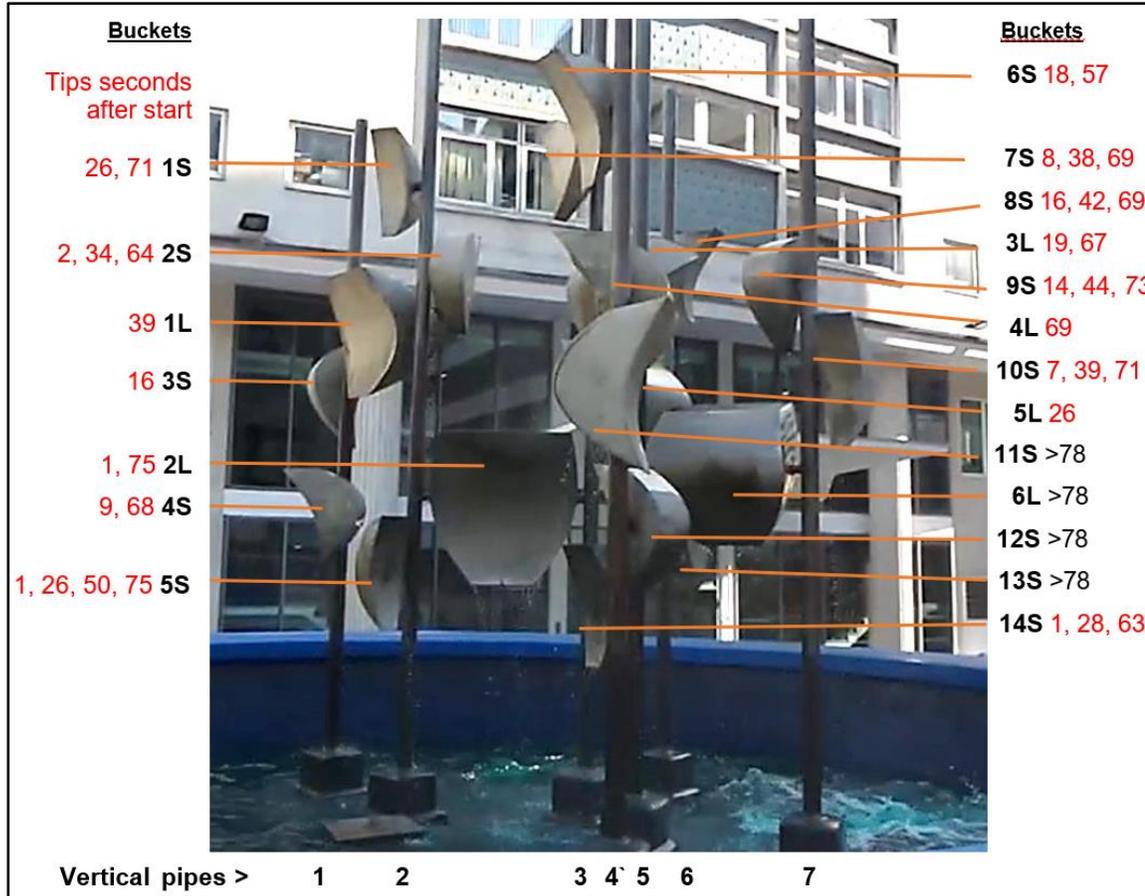
YouTube Video of August 2013 - Duration 78 Seconds

- Number of buckets shown tipping – 16 of 20
- Cascades shown - 36 (33 in first 71 seconds)
- Number of times 2 or more buckets tip together - 7
- Shortest tipping frequency of a bucket – 27 seconds

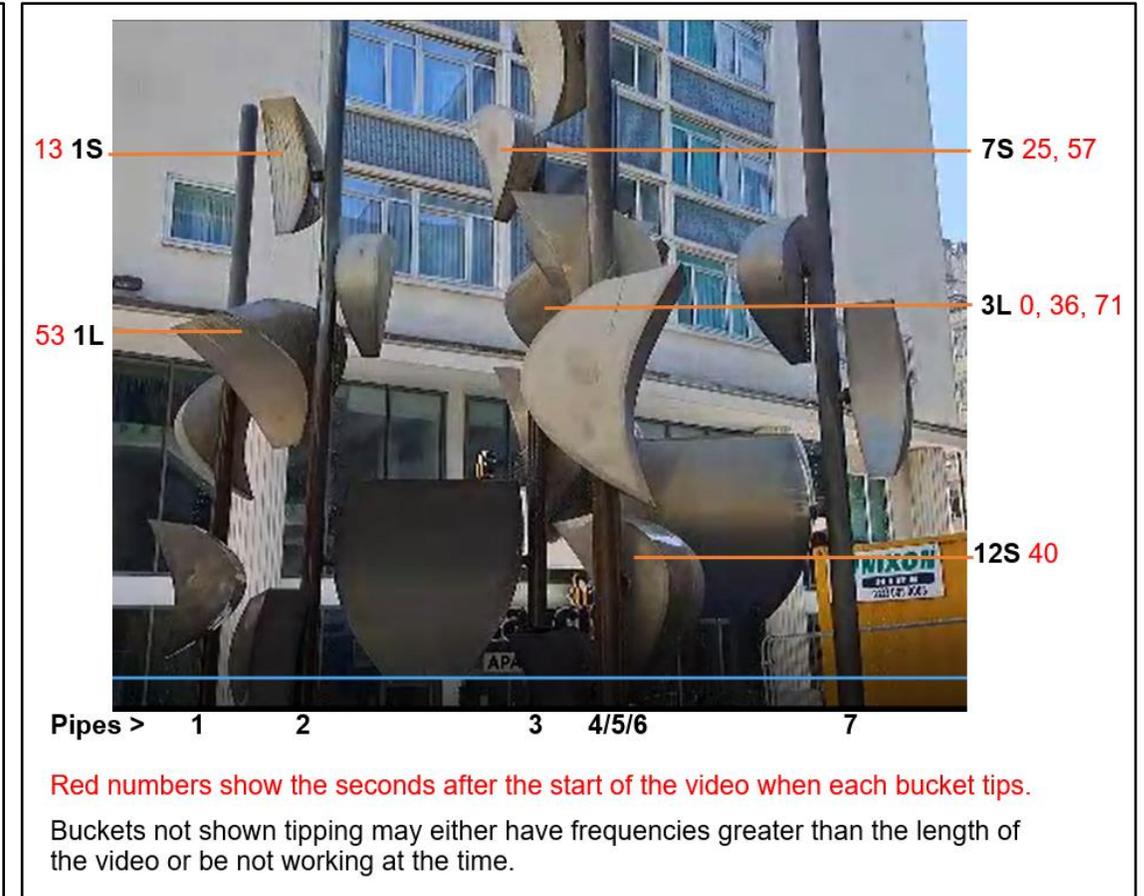
Friends of PF Video of June 2023 - Duration 71 Seconds

- Number of buckets shown tipping – 5 of 20
- Cascades shown - 8
- Number of times 2 or more buckets tip together - 0
- Shortest tipping frequency of a bucket - 32 seconds

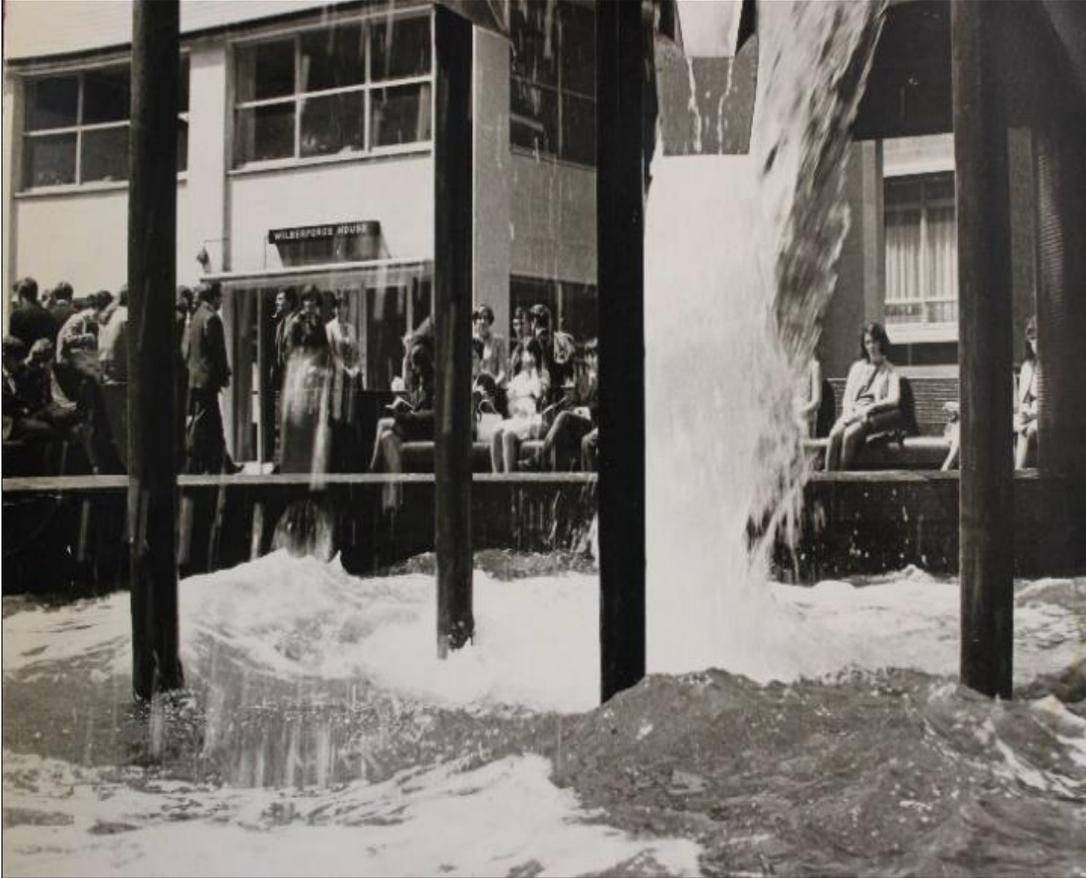
Original appearance with 420mm of water, 1967

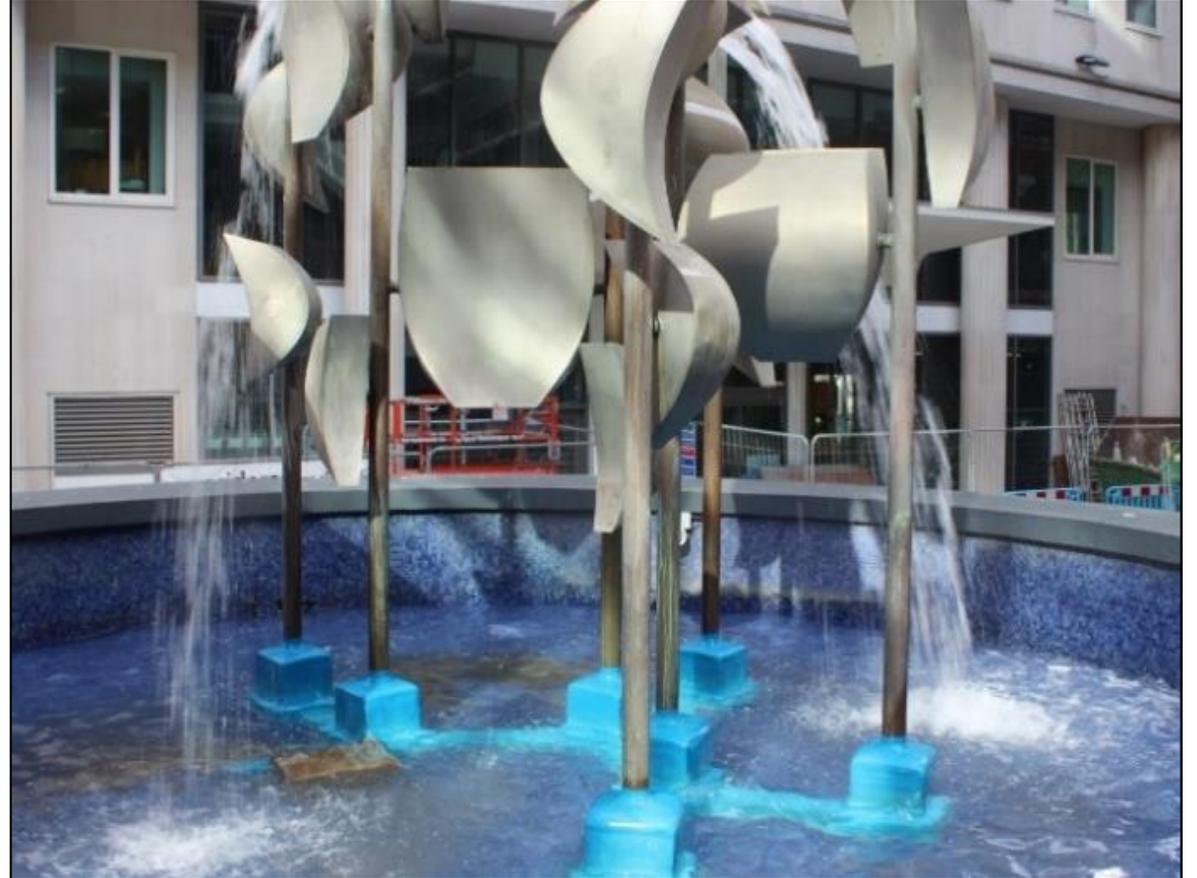
Current appearance with 100mm of water

Restoration will fulfil this reason for listing by restoring the 420mm water depth and the consequent wave movements and sounds

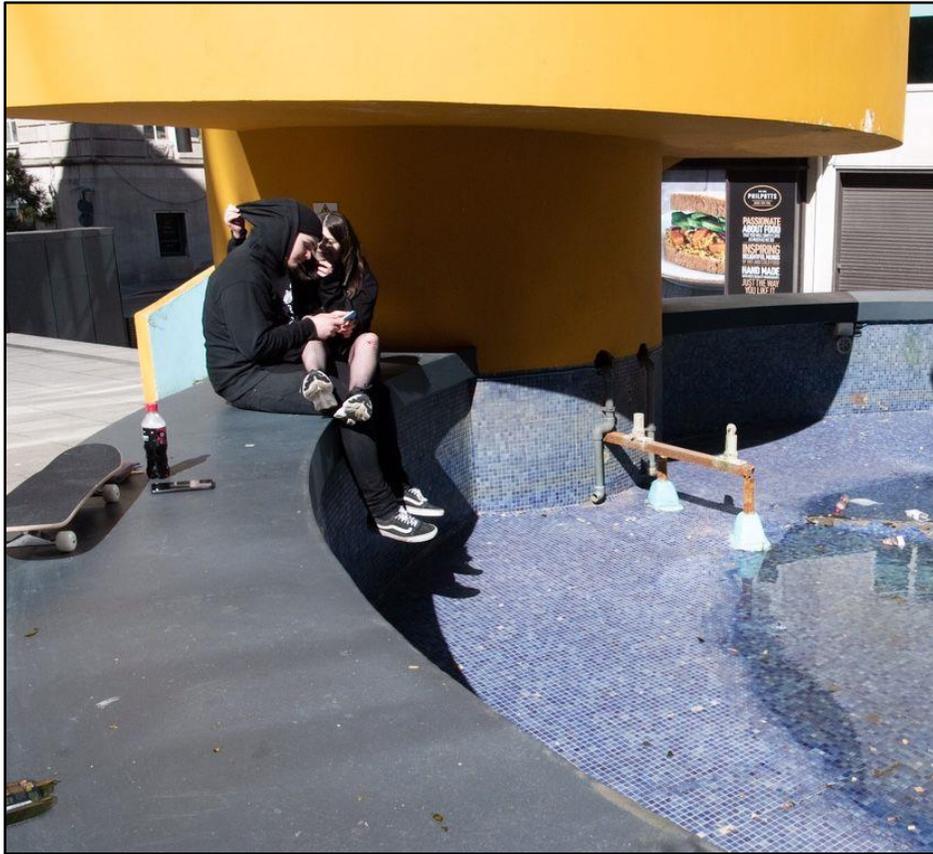
Current wide flat coping on low pool wall

Encourages children to climb onto, sit and stand on rim - increases risk of small children falling into new deeper water and invites others to paddle in pool.

Water depth above 100mm not considered safe.

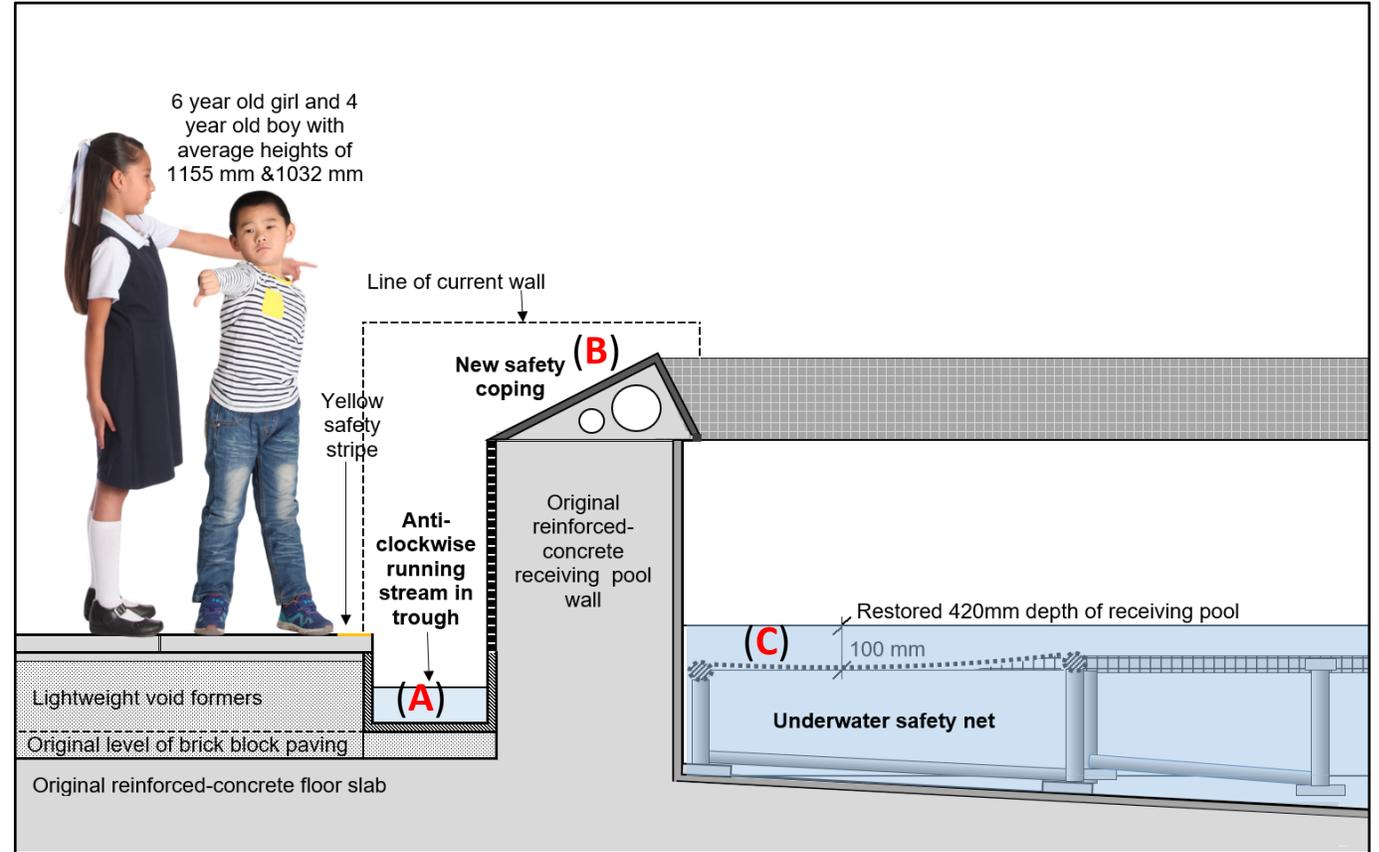
Three Possible Safety Measures

- A) Restore original thinner wall width & form shallow stream around base**
Provides barrier & distracting safe water feature for small children
- B) Replace flat coping with triangular safety coping**
Stops people from sitting, standing or walking on rim of pool
- C) Install a freestanding underwater safety net**
Catches small children still falling in & prevents paddling in pool

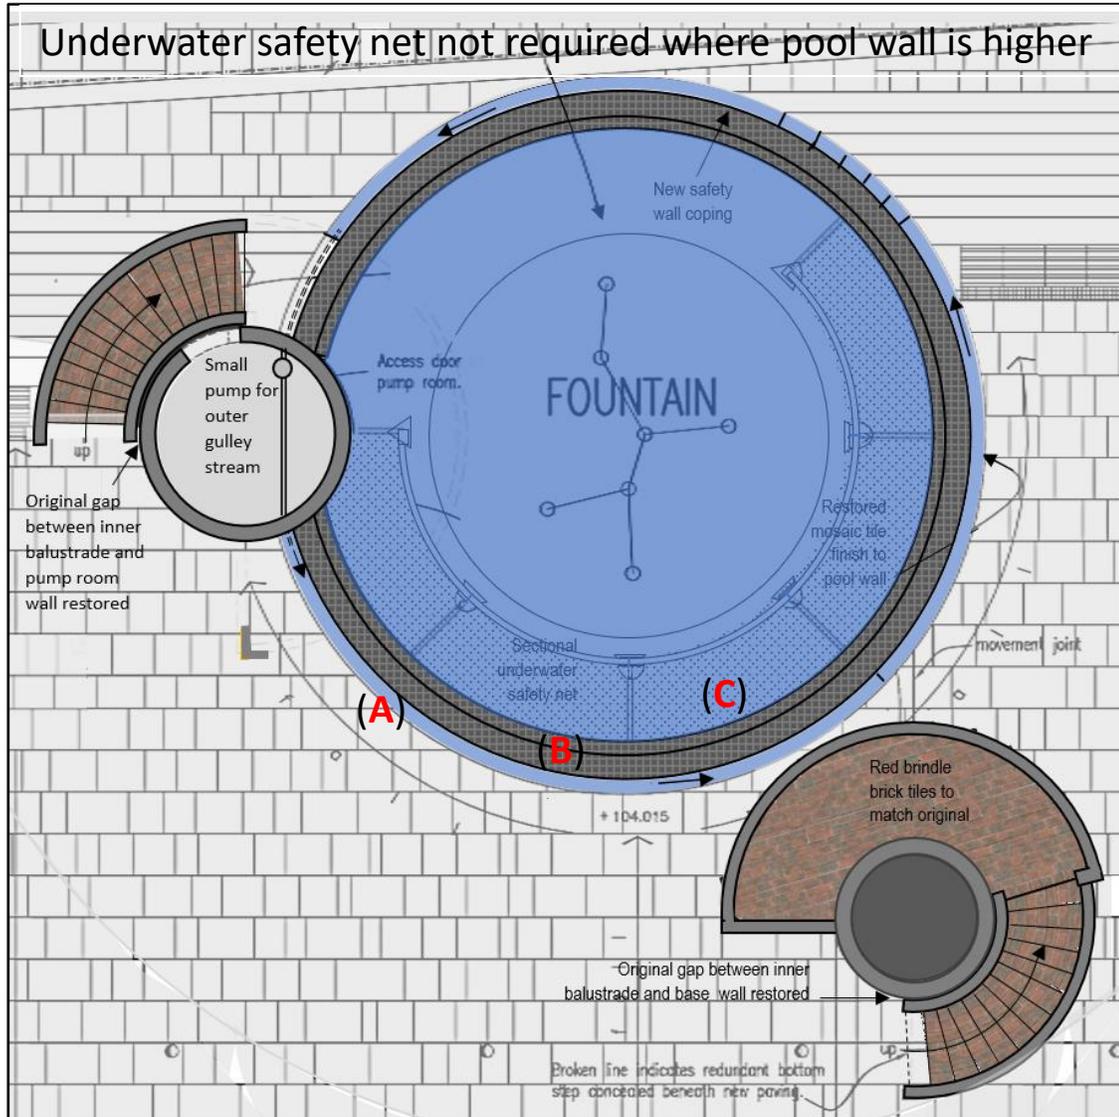
Plan of fountain complex, showing all 3 possible safety measures

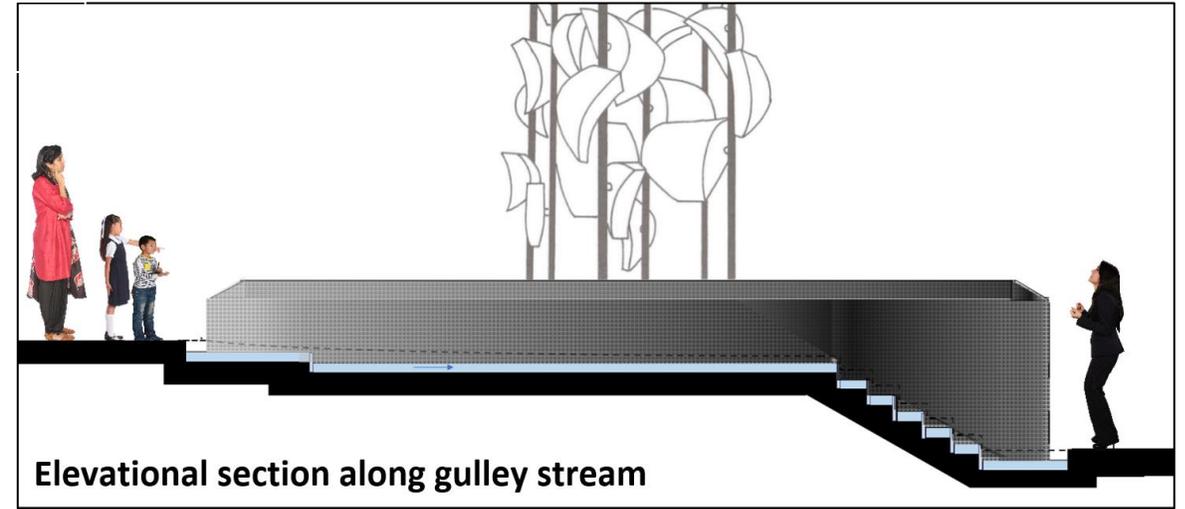
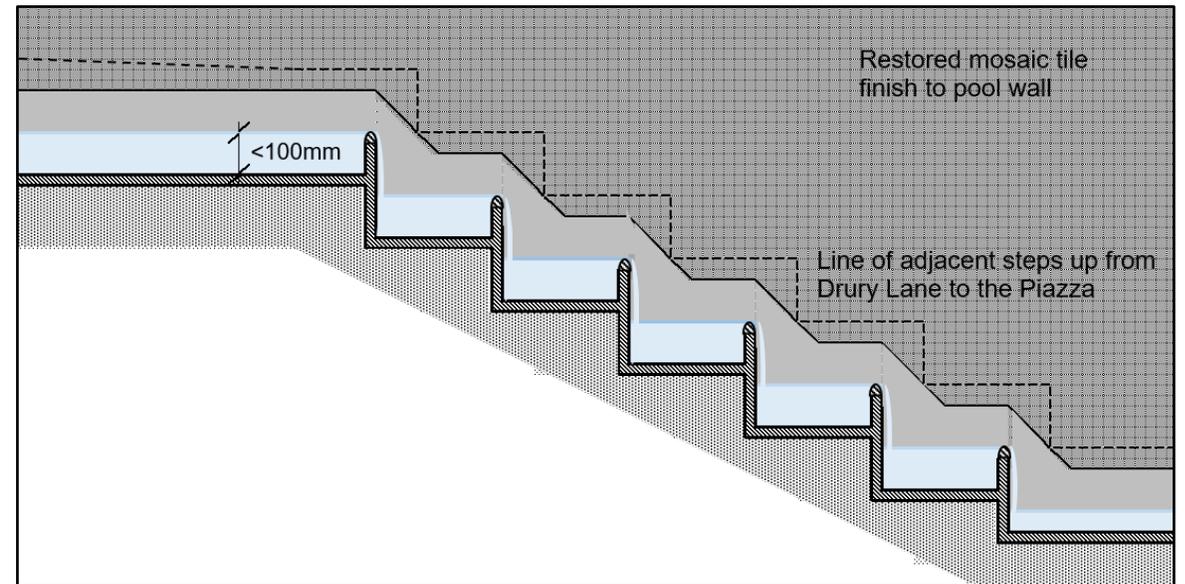
Section through mini cascades alongside steps from Drury Lane

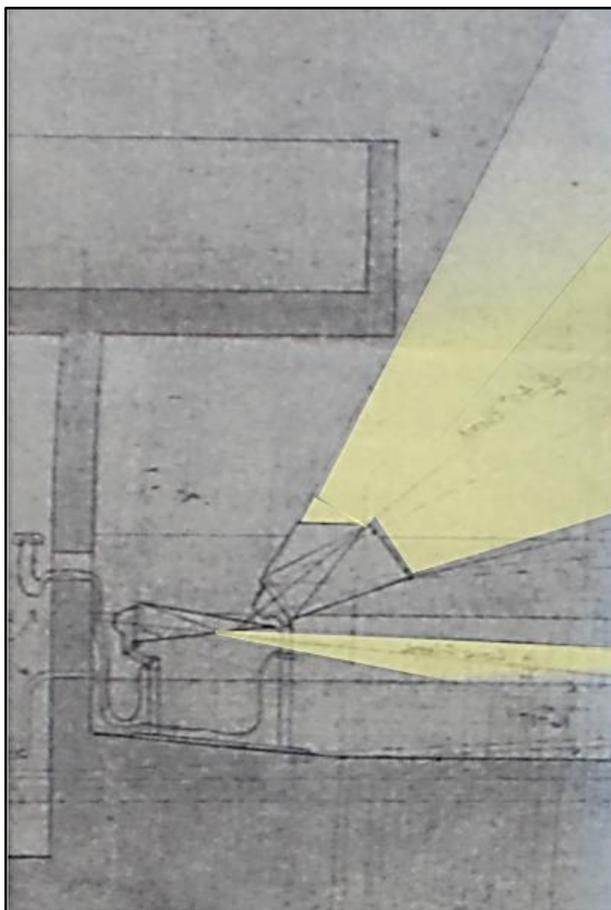
Design of original 2 freestanding floodlights in receiving pool

Broad 40 deg upward floodlight focussed on buckets/cascades

Narrow downfacing floodlight focussed on waves in pool

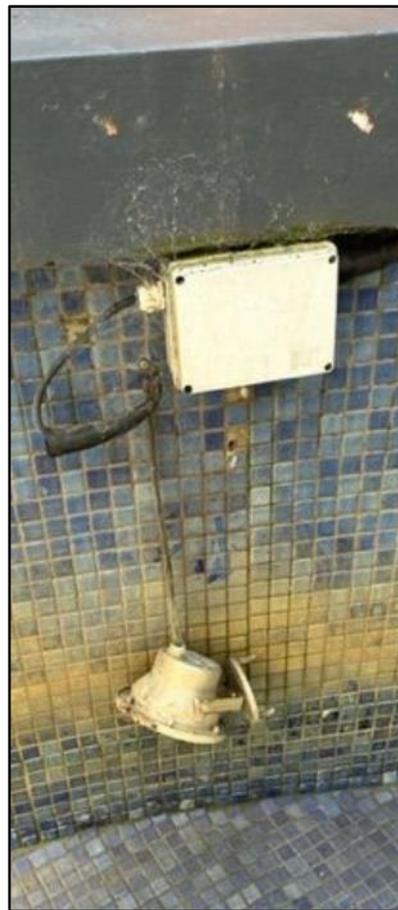
Current spotlights fixed to pool wall

(Shown torn off, but recently repaired)

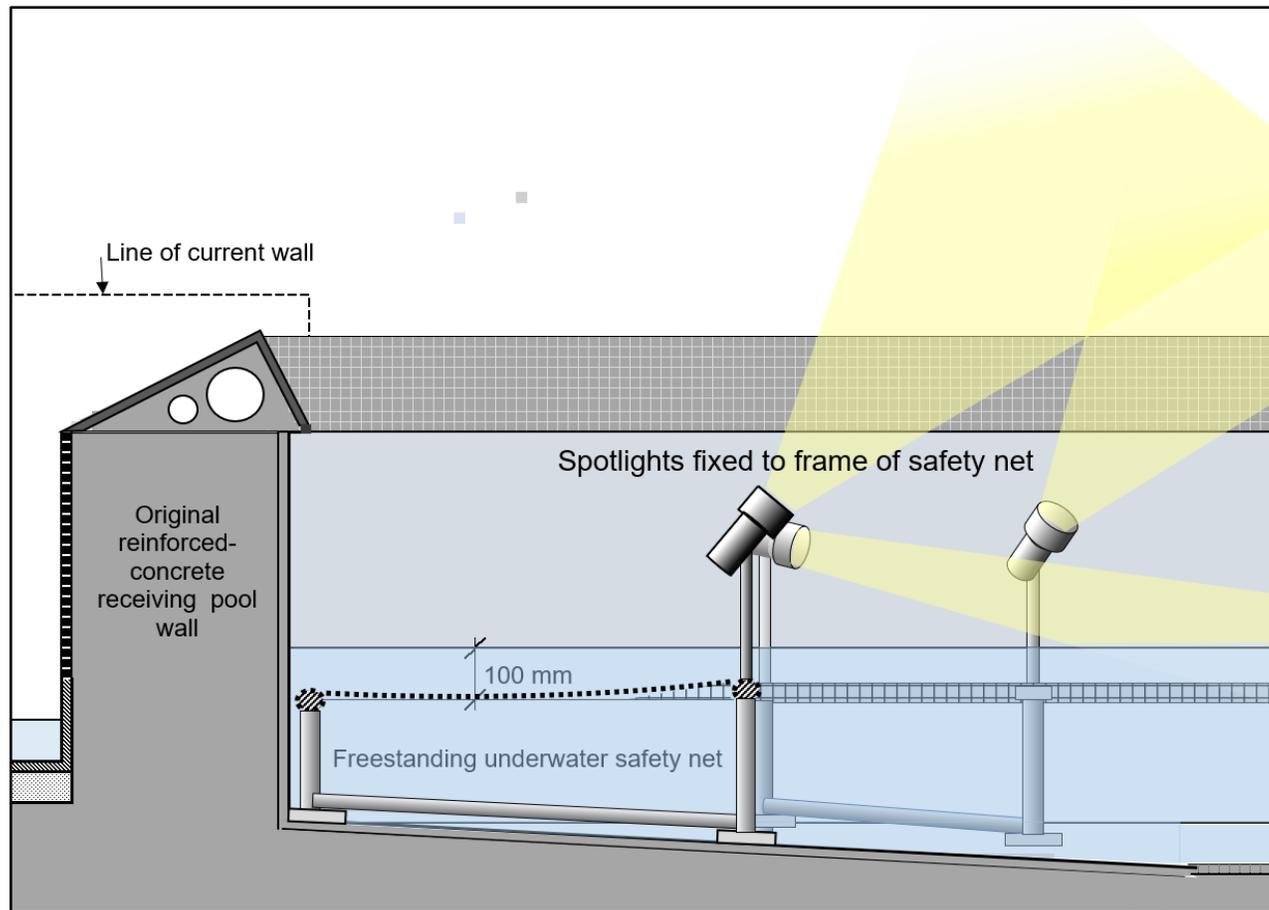
6 New Spotlights incorporated on freestanding frame of safety net Nearer to buckets and no longer in easy reach of vandals

Waterproof spotlights alternately focussed on buckets/cascades & resulting waves in the receiving pool

Wiring for spotlights fully concealed in tubular framework of safety net
