Restoration of the Piazza Fountain, Liverpool

Merseyside Civic Society

Restoration of the Piazza Fountain, Drury Lane, Liverpool

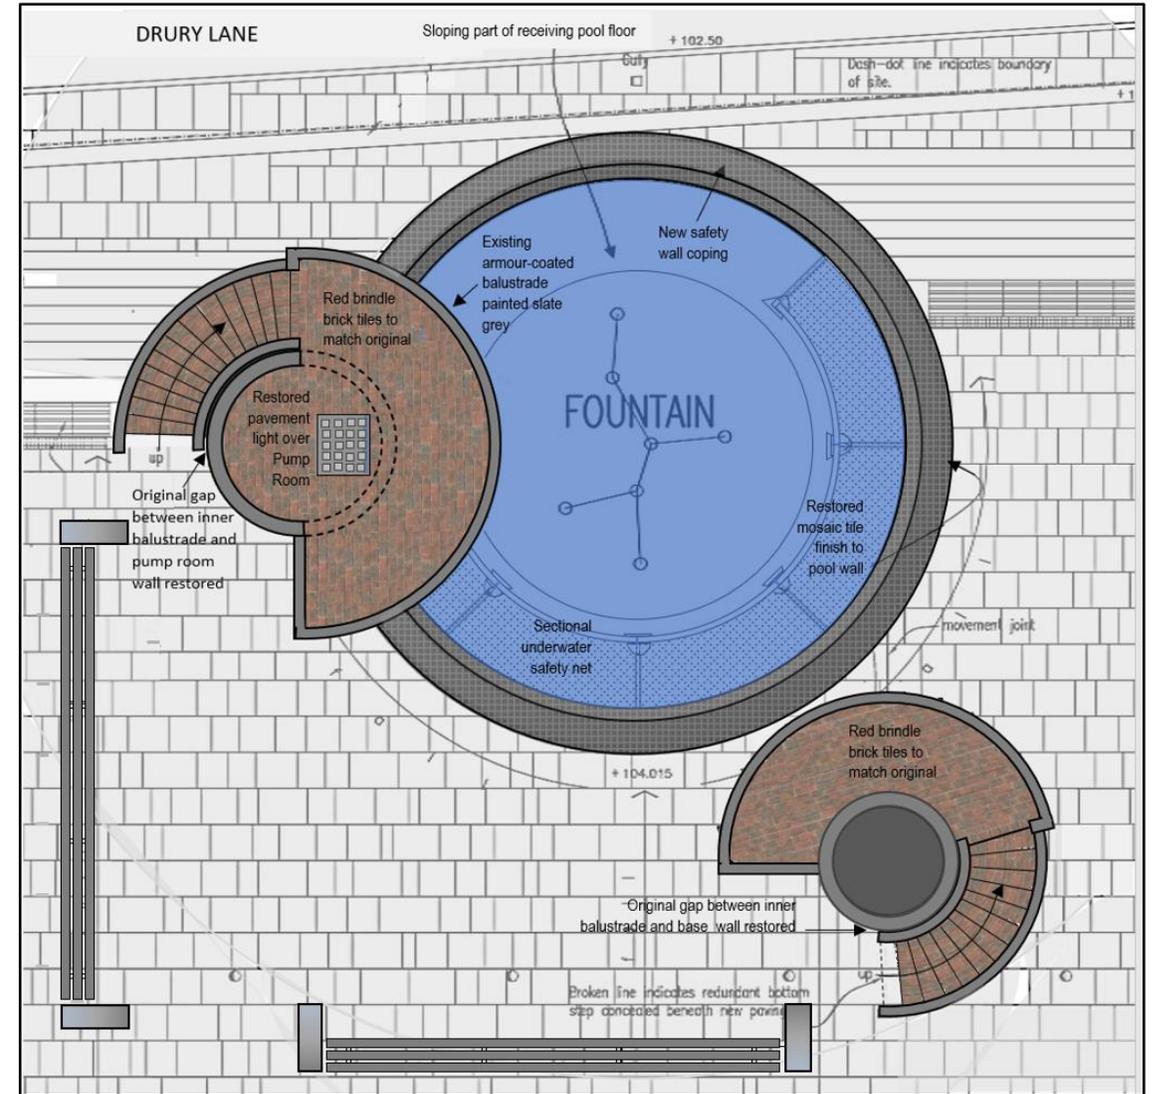
New bench seating (& litter bins) positioned to match original
Reinforced re-cycled plastic slats, stainless-steel supports & bins

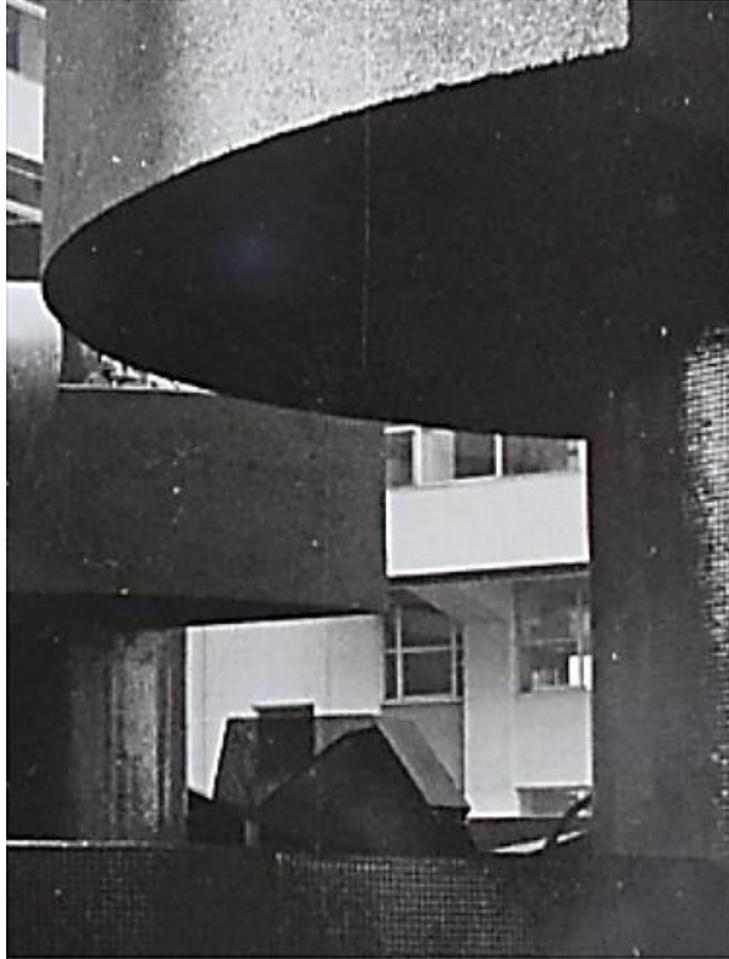
Original finishes of pool & platform walls

Richard Huws chose dark finishes to highlight the white cascades

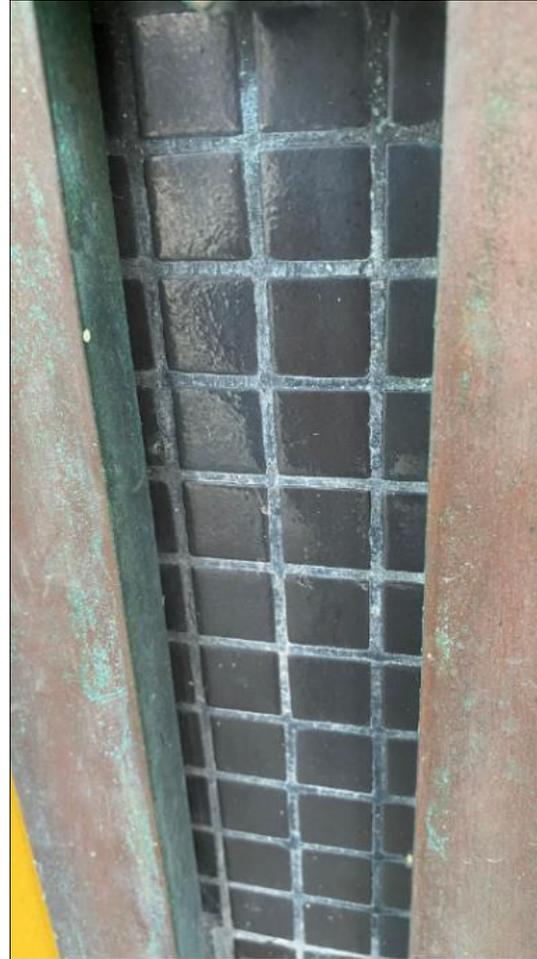
Surviving area of original black ceramic mosaic tiles

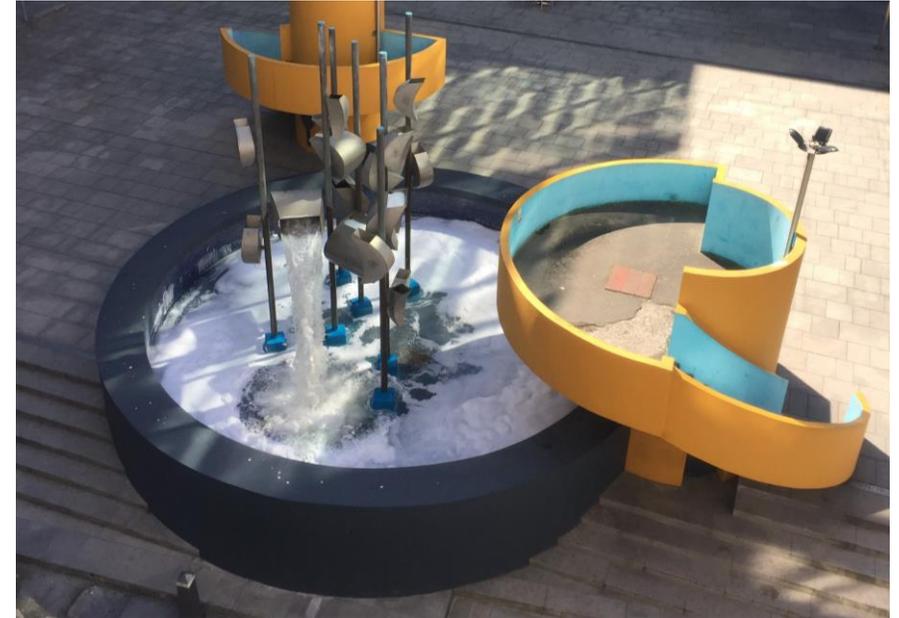
Current colour scheme on the all rendered walls

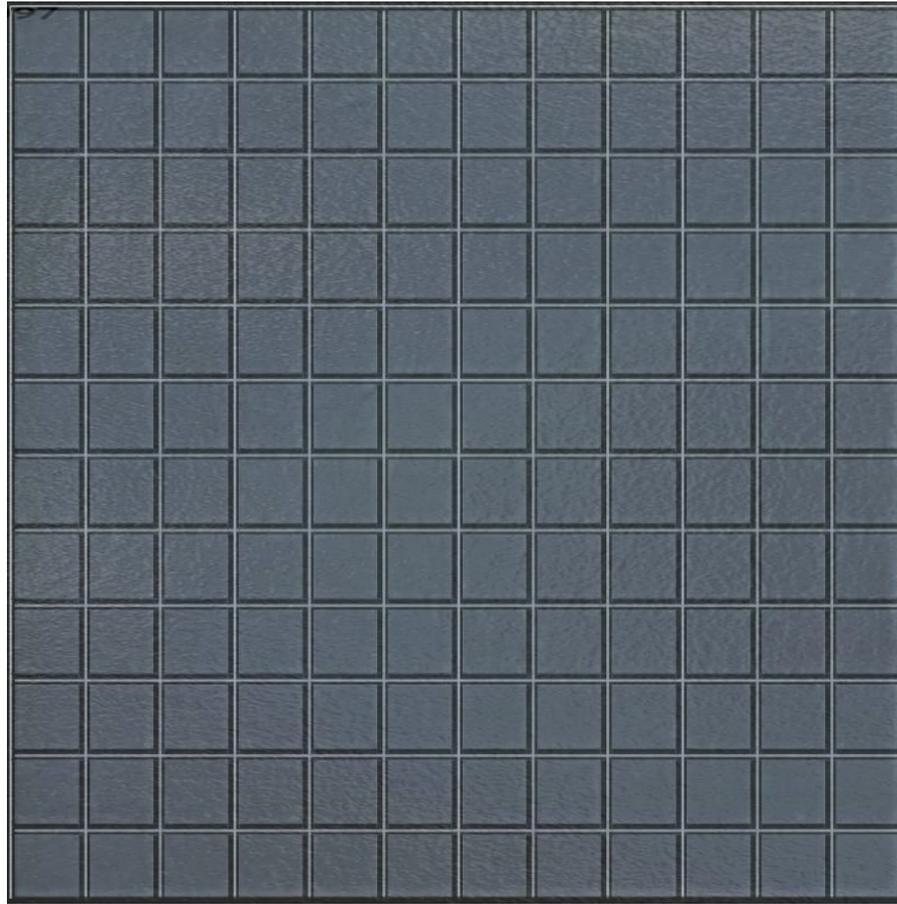
Proposed use of Cwt-y-Bugail Dark Blue Grey polished Welsh slate mosaic 'tiles'.
(300 mm x 300mm sheet prior to grouting)

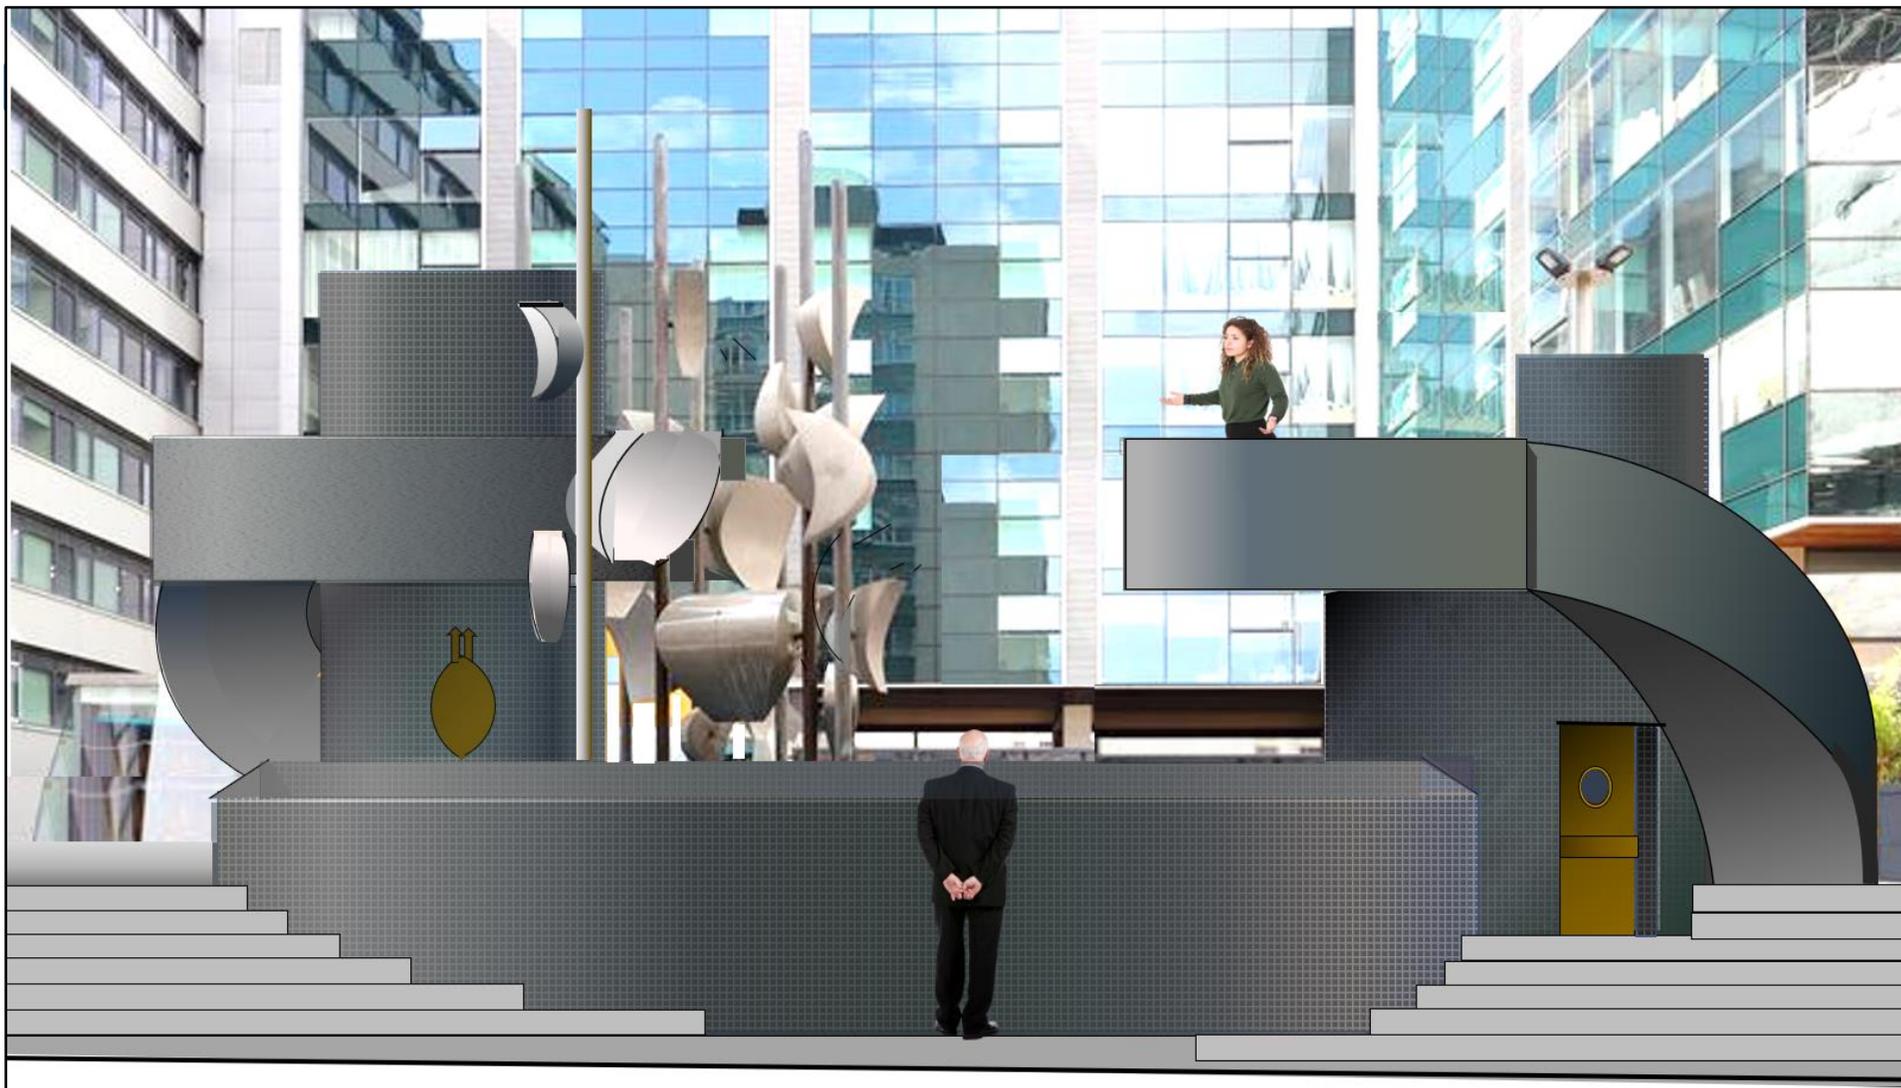
Piazza Fountain Elevation to Drury Lane

Use of Cwt-y-
Bugail Dark Blue
Grey Welsh slate
tiling and
matching paint

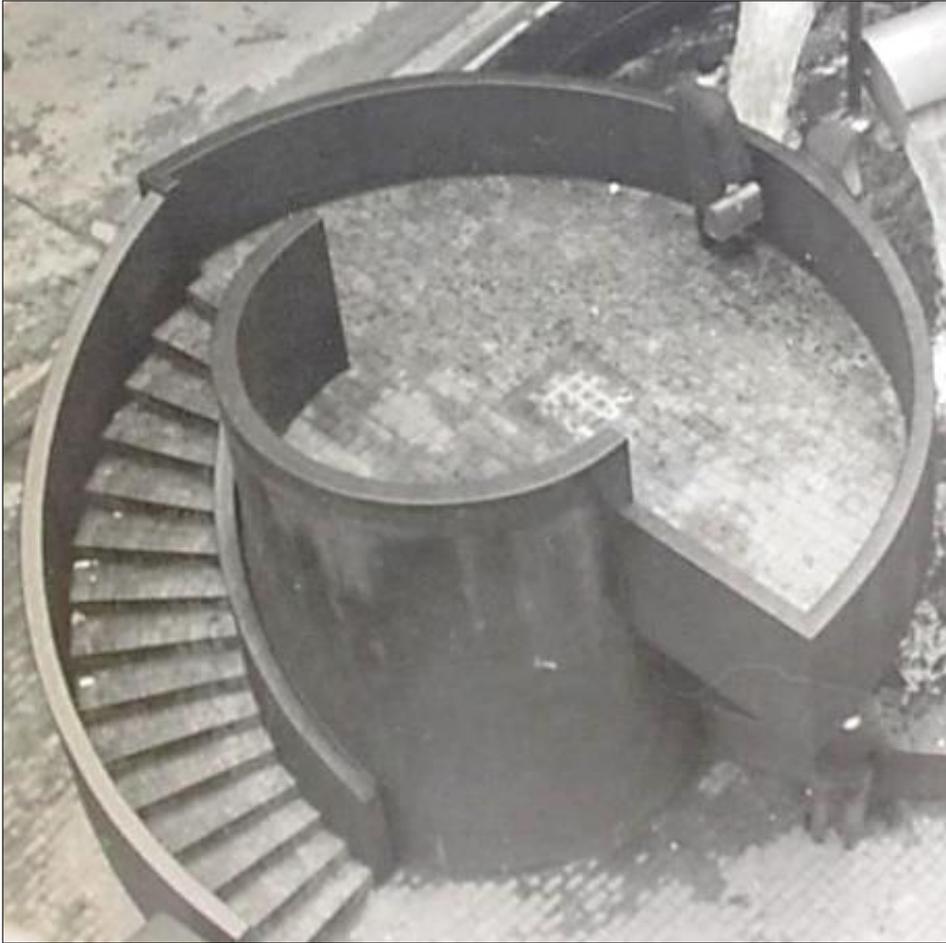
Original brindle red tiling to platforms & stairs
Stairs relined with dunbar chequer plate steel

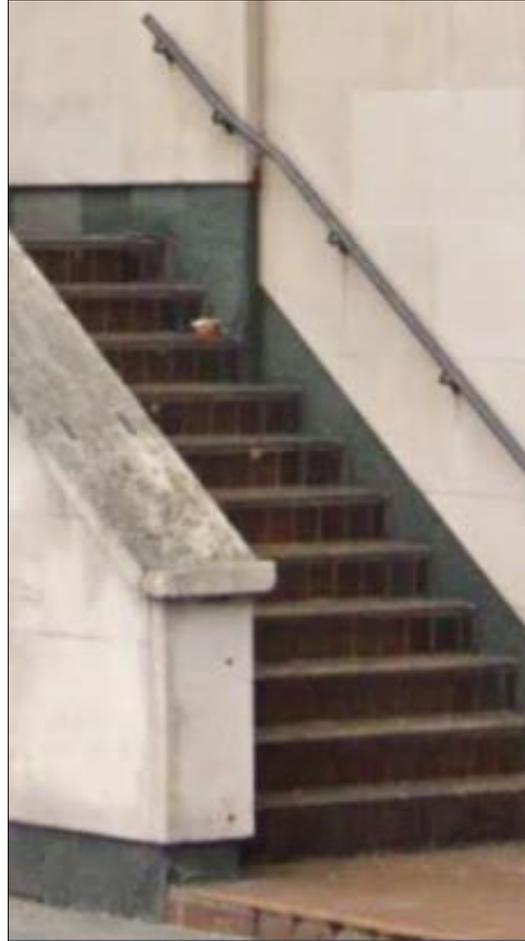
**Surviving bridle red tiles
on stairs from the Strand**

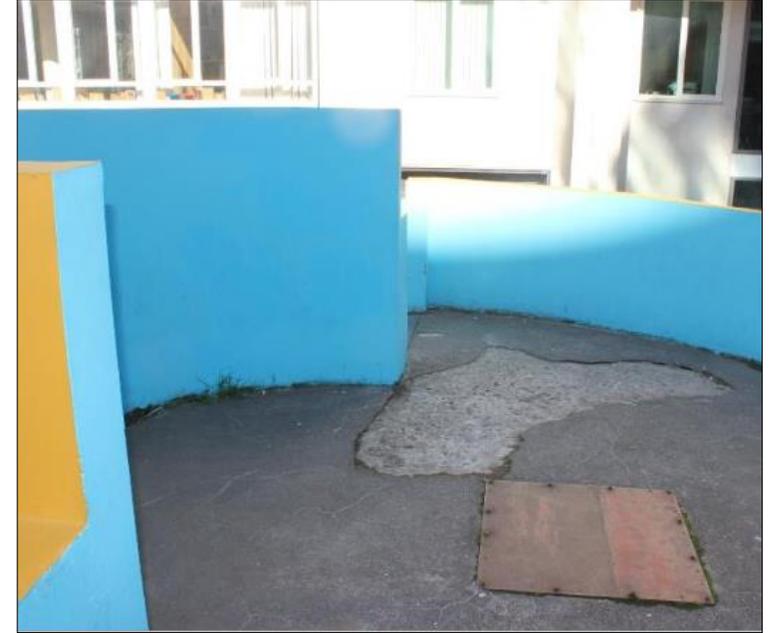
**Current disintegrating asphalt floor
finish to viewing platforms**

Asphalt to be replaced with original
red brindle brick tiling

Plywood covered pavement light to
pump room to be also restored

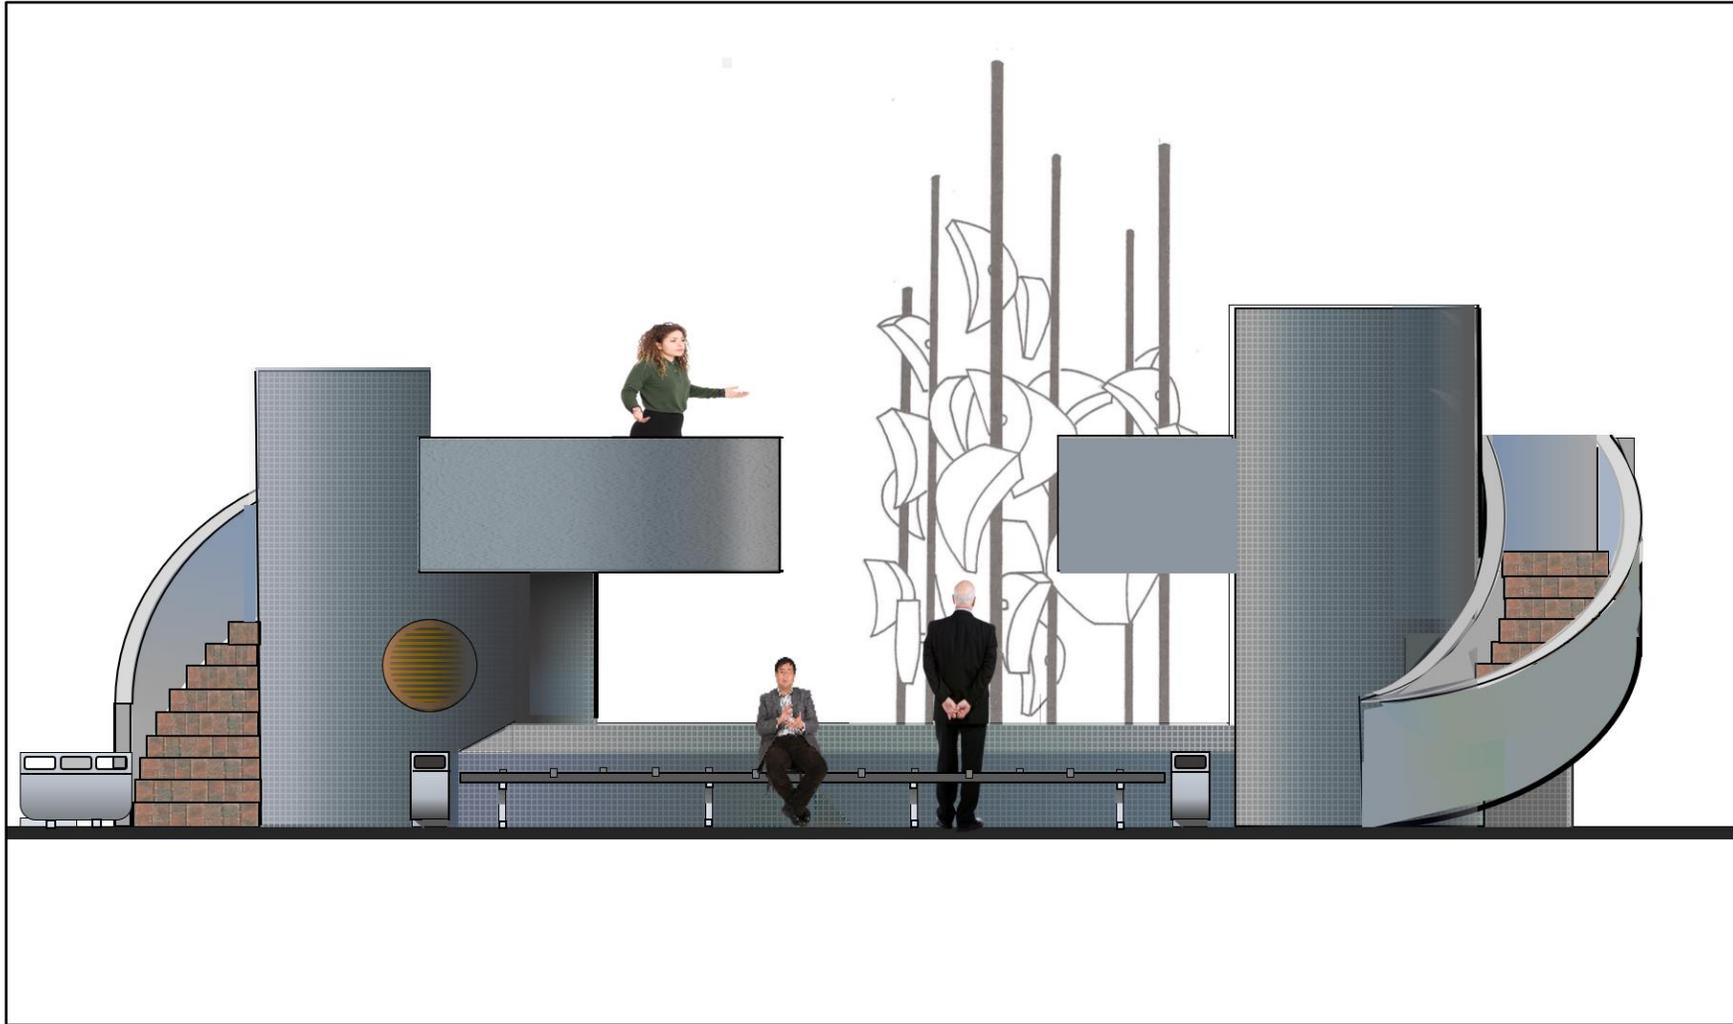
**Piazza Fountain, Elevation to the Piazza showing restored stair finish
(and proposed reinstated seating, litter bins and bronze restoration plaque)**

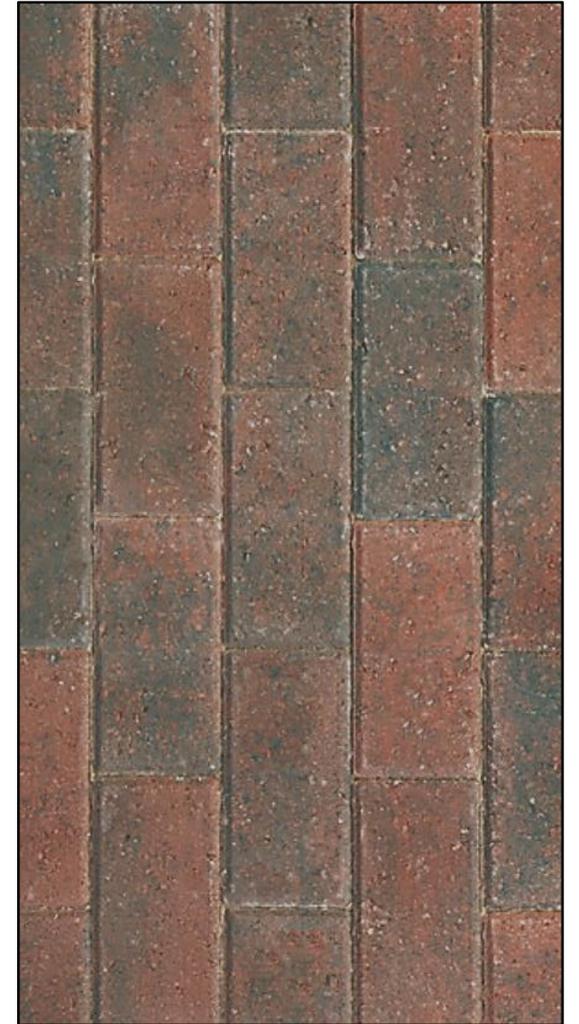
**Brindle red brick tiles
matching original tiling**
