Restoration of the Piazza Fountain, Liverpool

- Richard Huws' sole surviving fountain
- Earliest & finest of only 2 'bucket' fountain in the World
- One of Historic England's "*most fascinating*" listings

Merseyside Civic Society

2: Restoration of the Piazza Fountain, Drury Lane, Liverpool

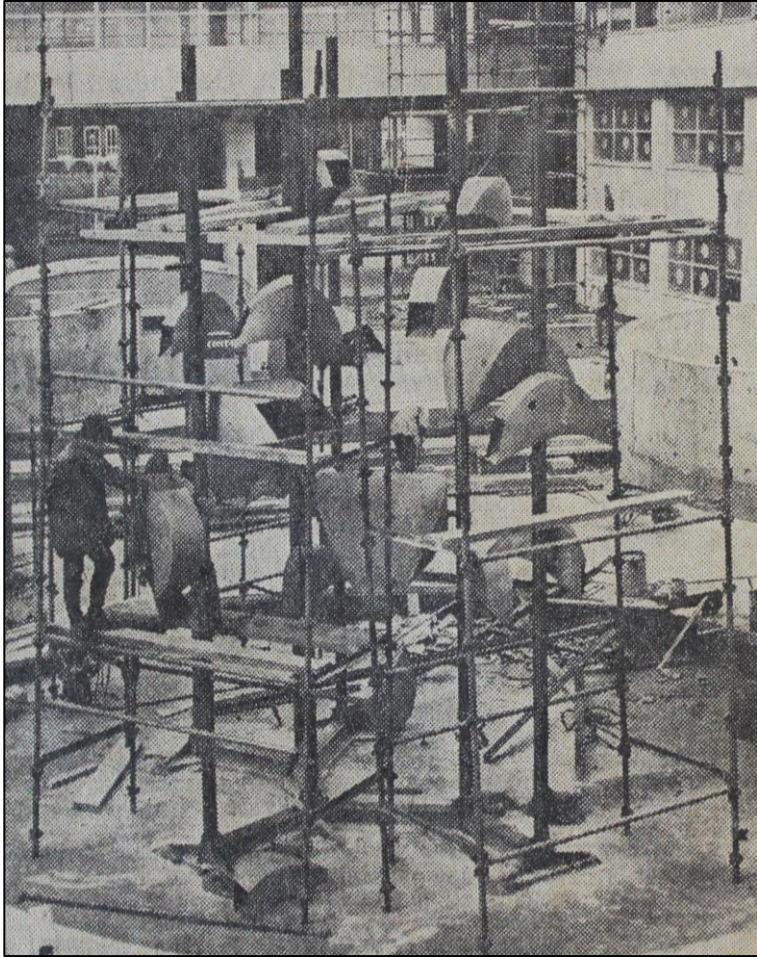
Installation of fountain, 1966/67

Showing original metal manifold base

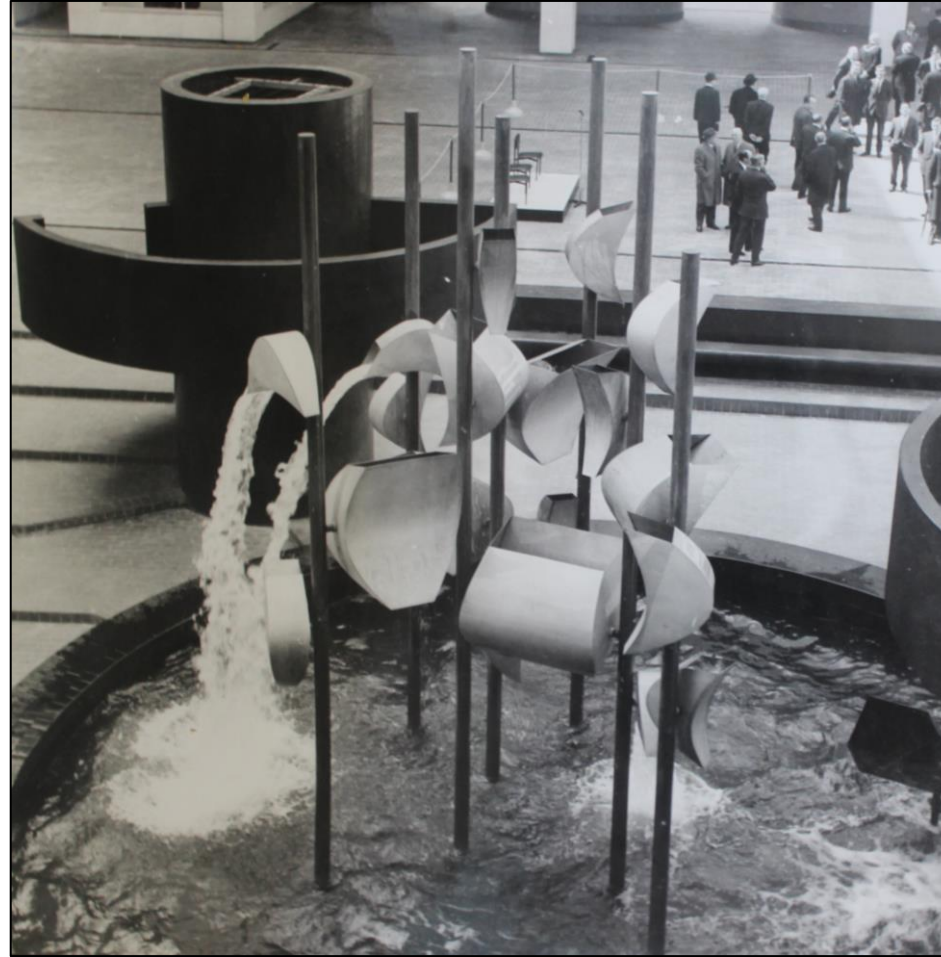
Opening 2/5/1967: Fountain rises out of water

Base fully concealed under waves & white water

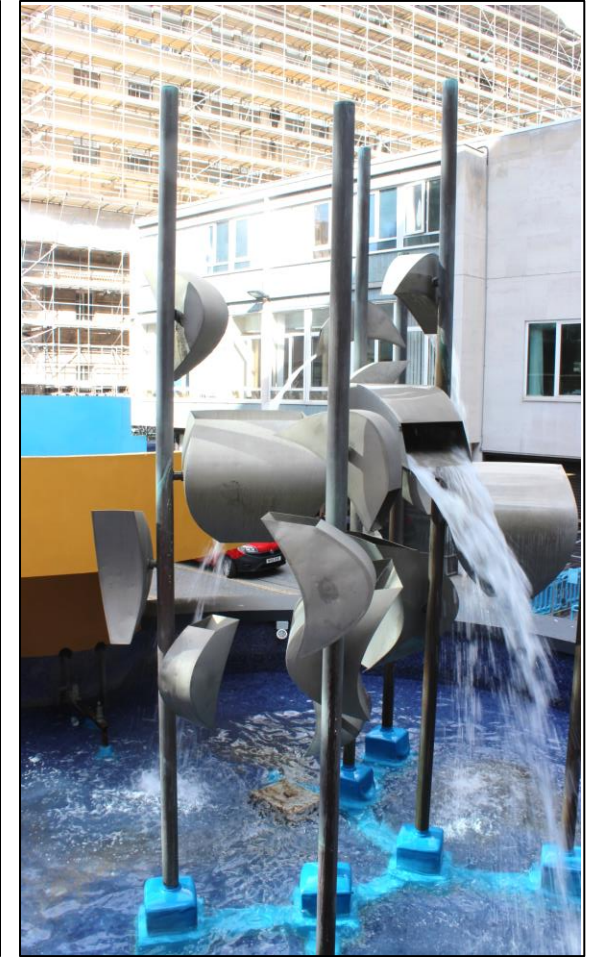
Current blue base

Encased & very prominent

- ❑ Original manifold base strengthened by encasing in concrete and fountain height reduced by some 400mm (possibly prior to 1997)
- ❑ New bright blue waterproof covering applied to concrete (circa late 2017 or early 2018 - recently re-painted)

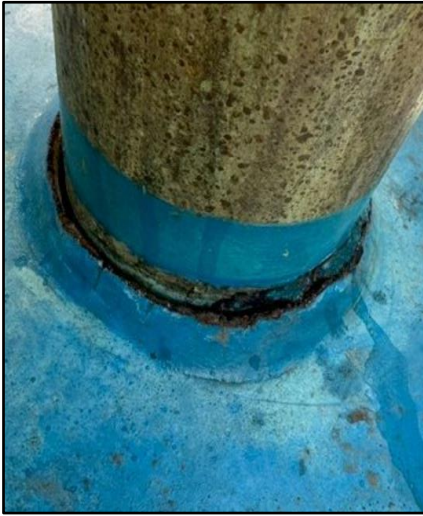
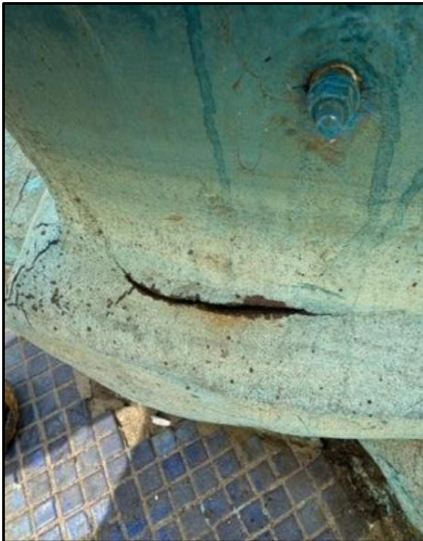
Cracks in existing base

(recently patched up and repainted)

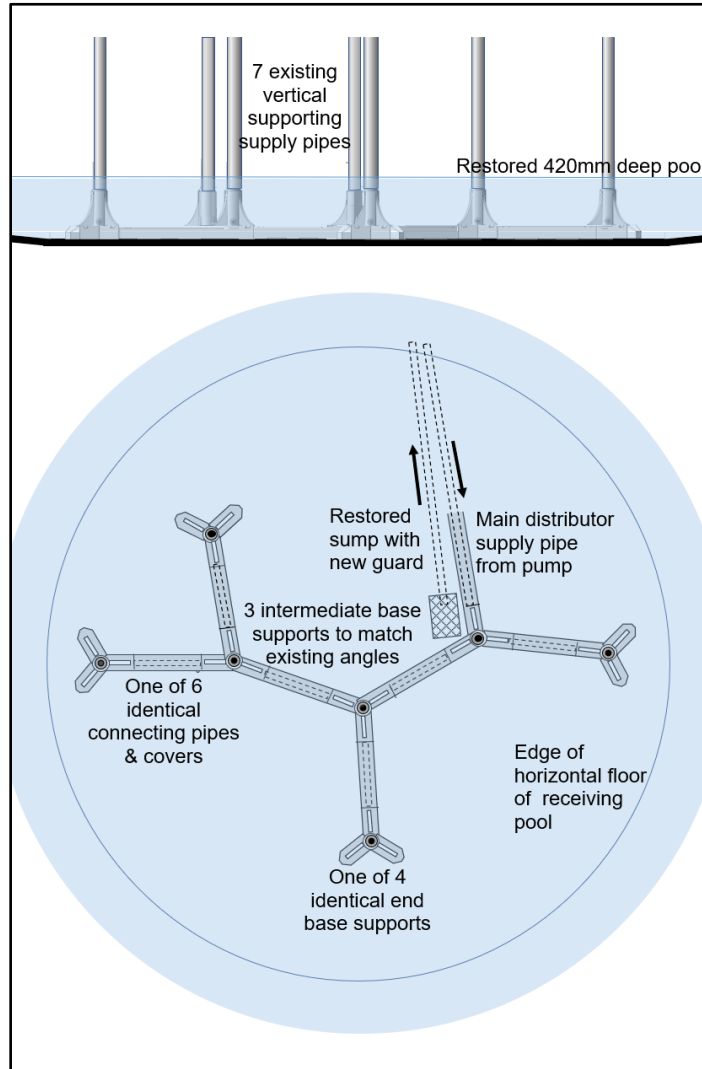
Elevation & plan of new manifold

Fabricated in 7 base & 6 connecting parts all dismantlable for future maintenance

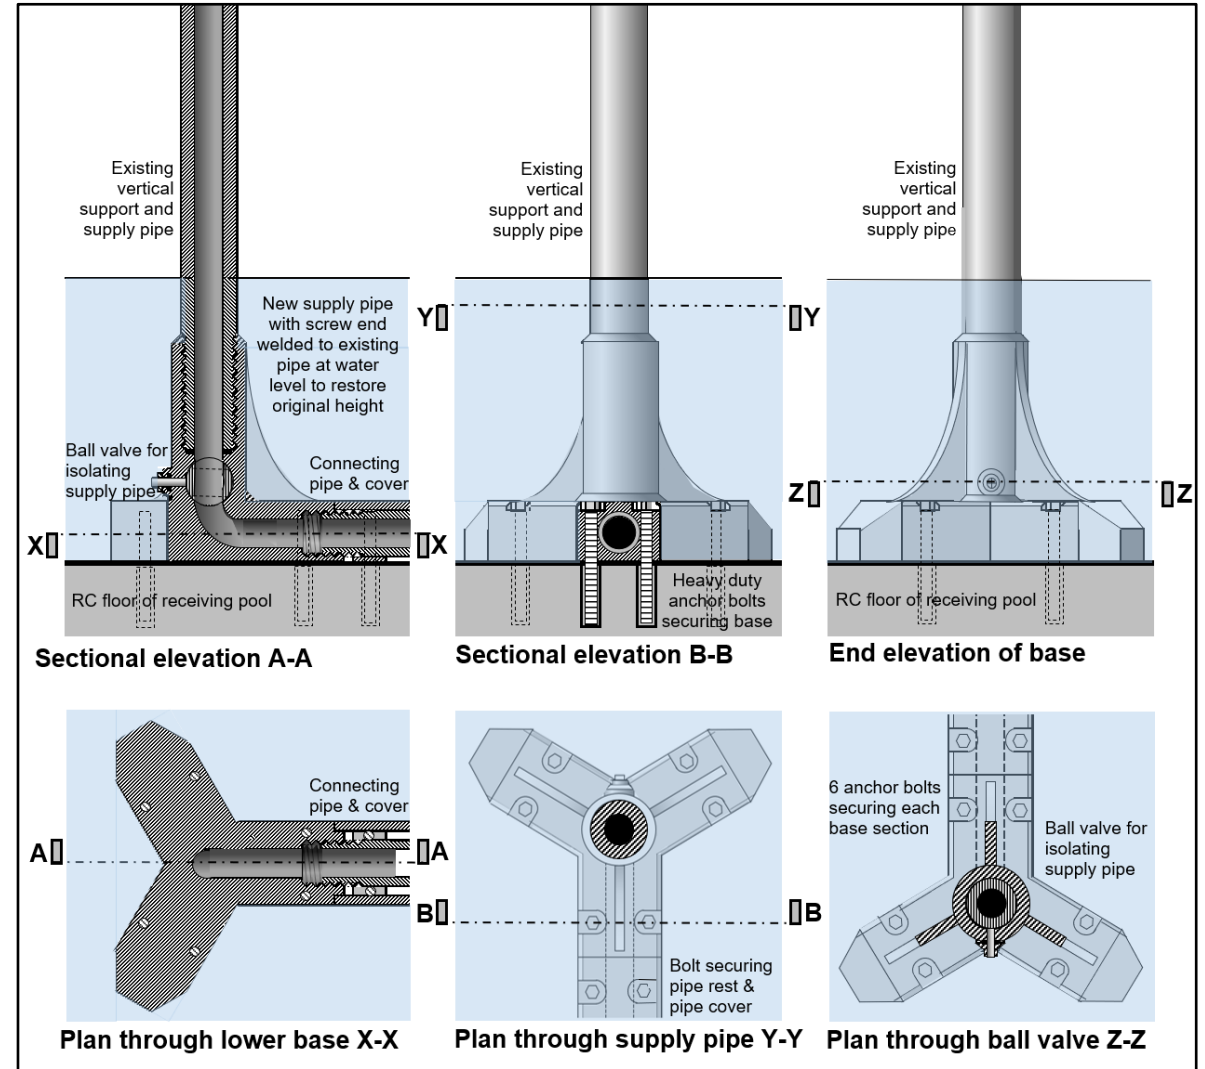
Sections, elevations & plans of a standard end base part

New supply pipes welded to bottom of existing 7 verticals at water level and screwed into bases to restore original height of fountain

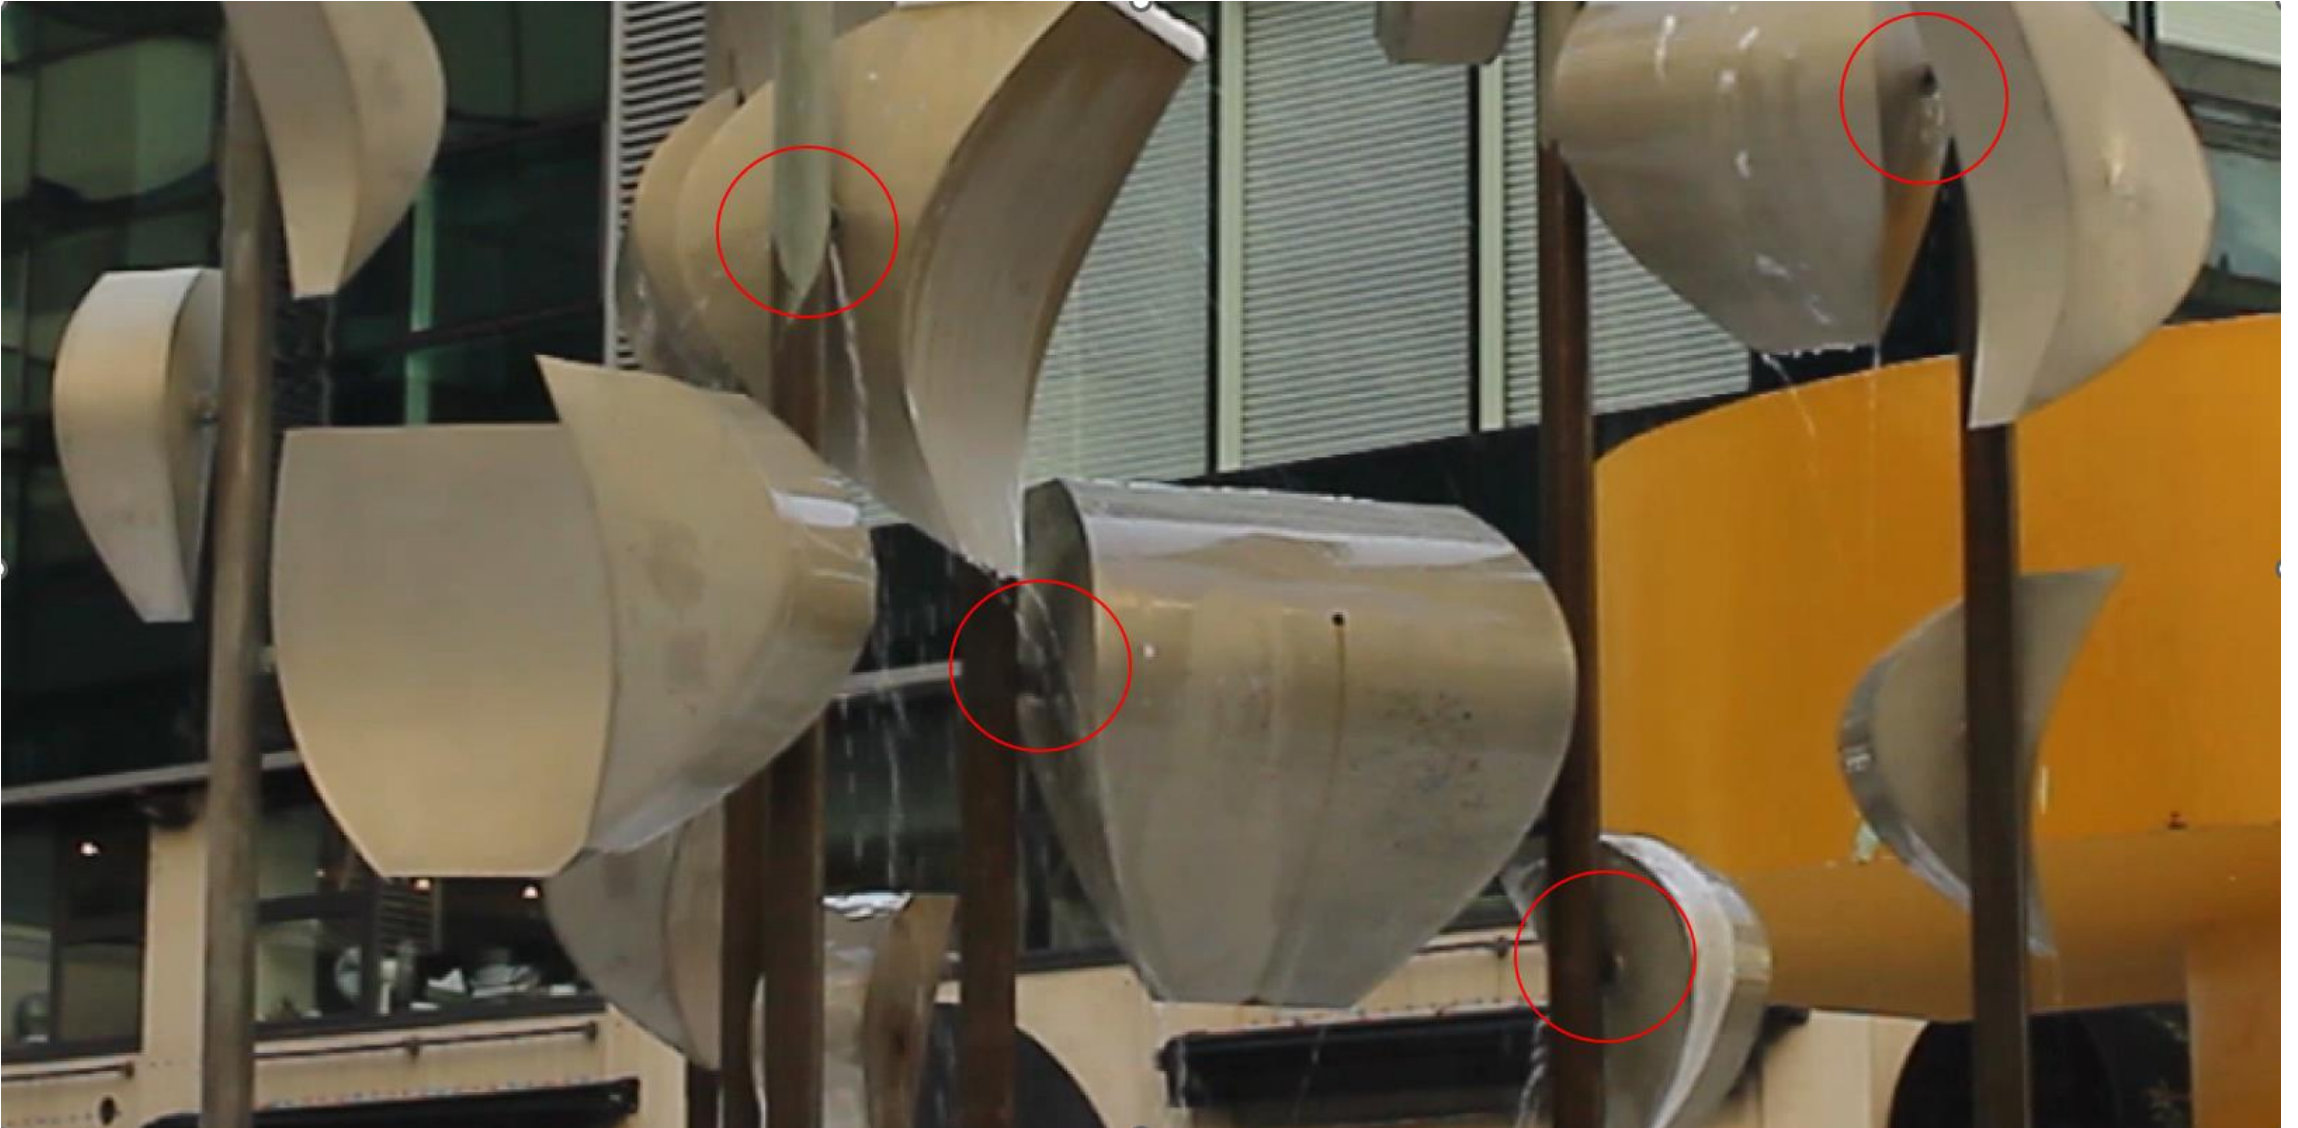
Photograph of the Leaking Piazza 'Bucket' Fountain (Buckets leak once filling water reaches central axle/supply pipe)

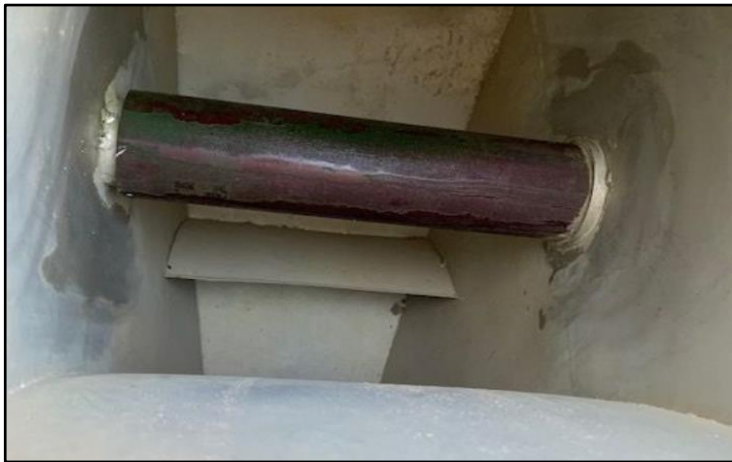
Cylindrical 'Tufnol' hopper sleeve
through centre of smaller hopper/bucket

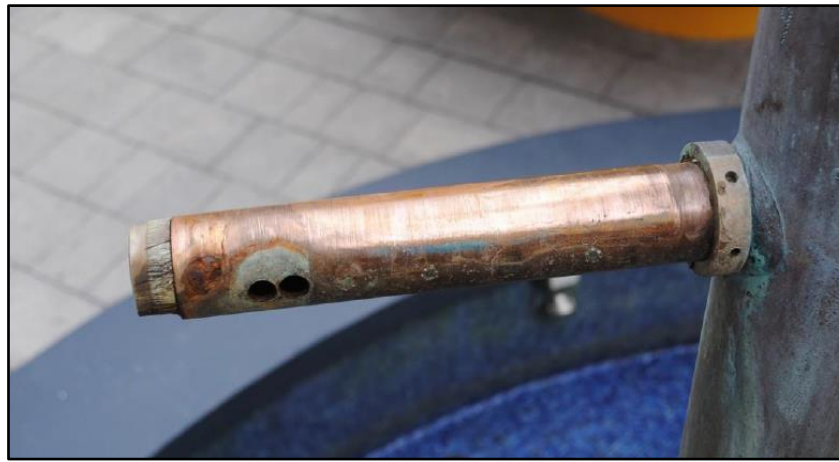
Worn bronze supply pipe/axle
causing leaks between axle and 'Tufnol' sleeve

- 1) Replace all worn bronze axles/supply pipes** (with more wear/corrosion resistant cupronickel or phosphor bronze pipes)
- 2) Weld new stainless-steel housing to side of hoppers/buckets** (to replace projecting TUFNOL sleeve & existing fittings)
- 3) Pressure fit new radial shaft seal in housing** (flexible lip of seal held tight against new axles by water pressure)
- 4) Secure seal in place by new stainless-steel clamping plate** (Remove to renew seal as required)

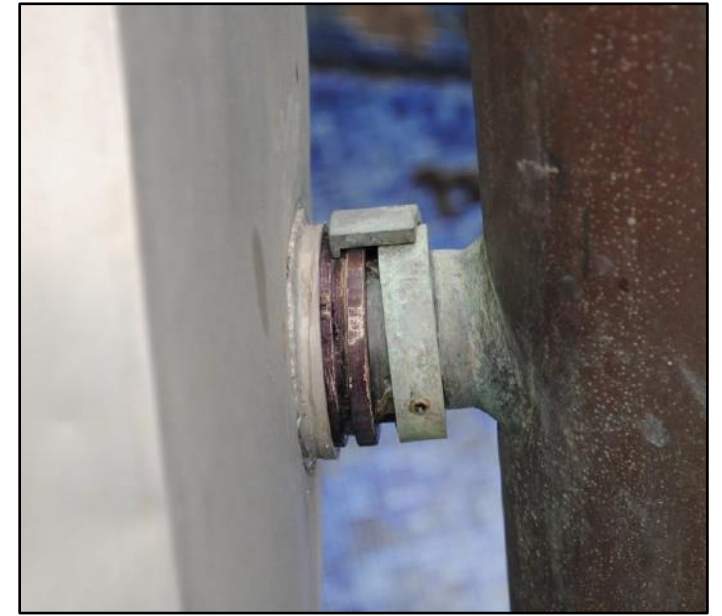
Half round fitting removed
shows areas from which 'buckets' leak

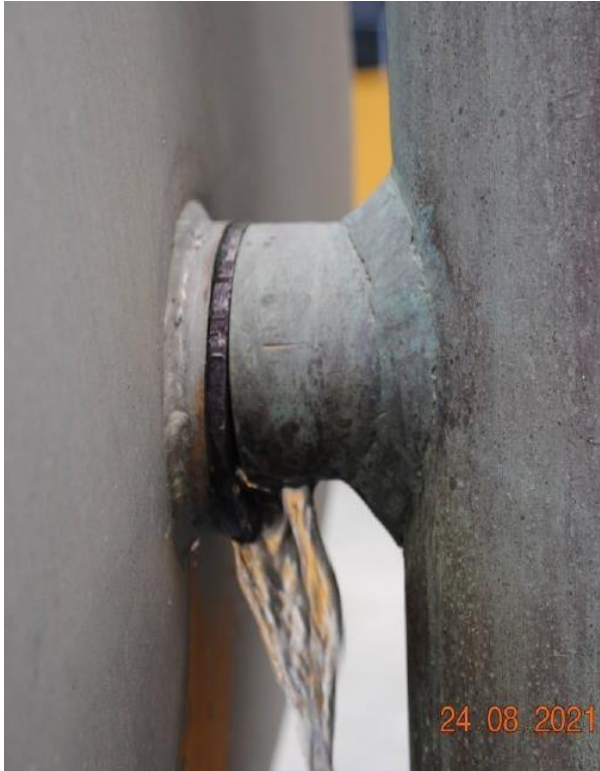
Drop & leak on larger 'bucket'
Cause as for smaller buckets

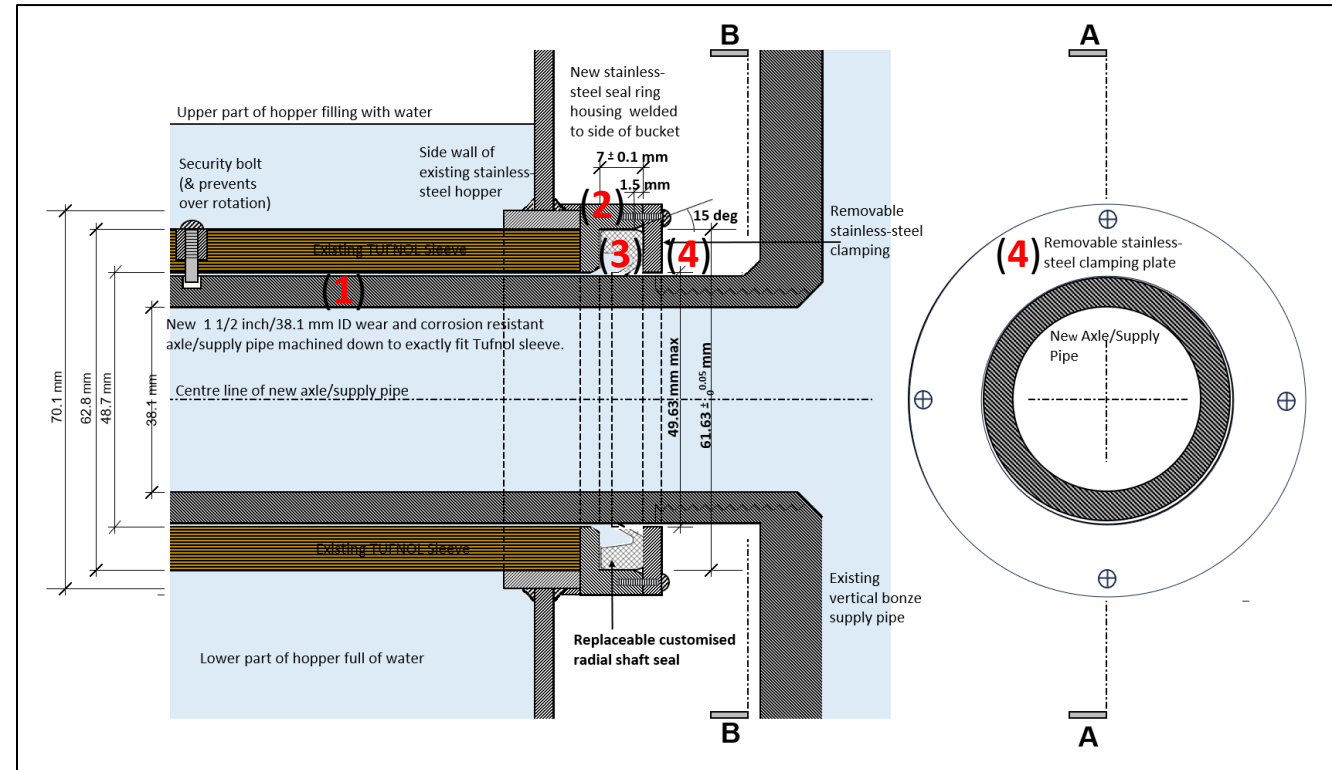
Proposed customised seal in new stainless-steel ring housing
welded to side of existing hoppers & secured by new clamping plate

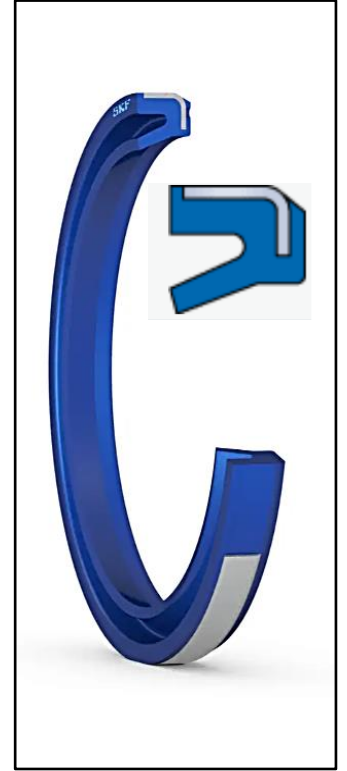
Similar MCW wiper seal

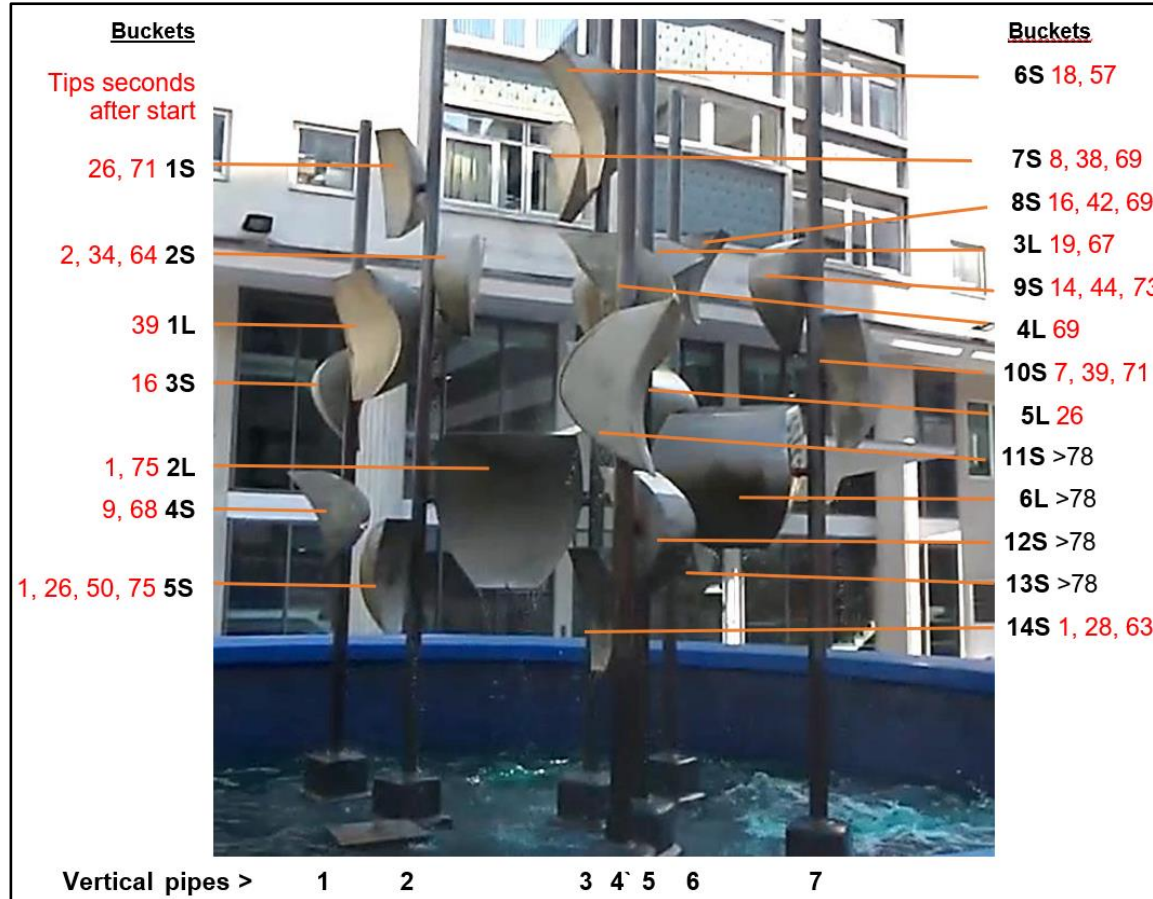
YouTube video of August 2013 - Duration 78 seconds

- Number of buckets shown tipping – 16 of 20
- Cascades shown - 36 (33 in first 71 seconds)
- Number of times 2 or more buckets tip together - 7
- Shortest tipping frequency of a bucket – 27 seconds

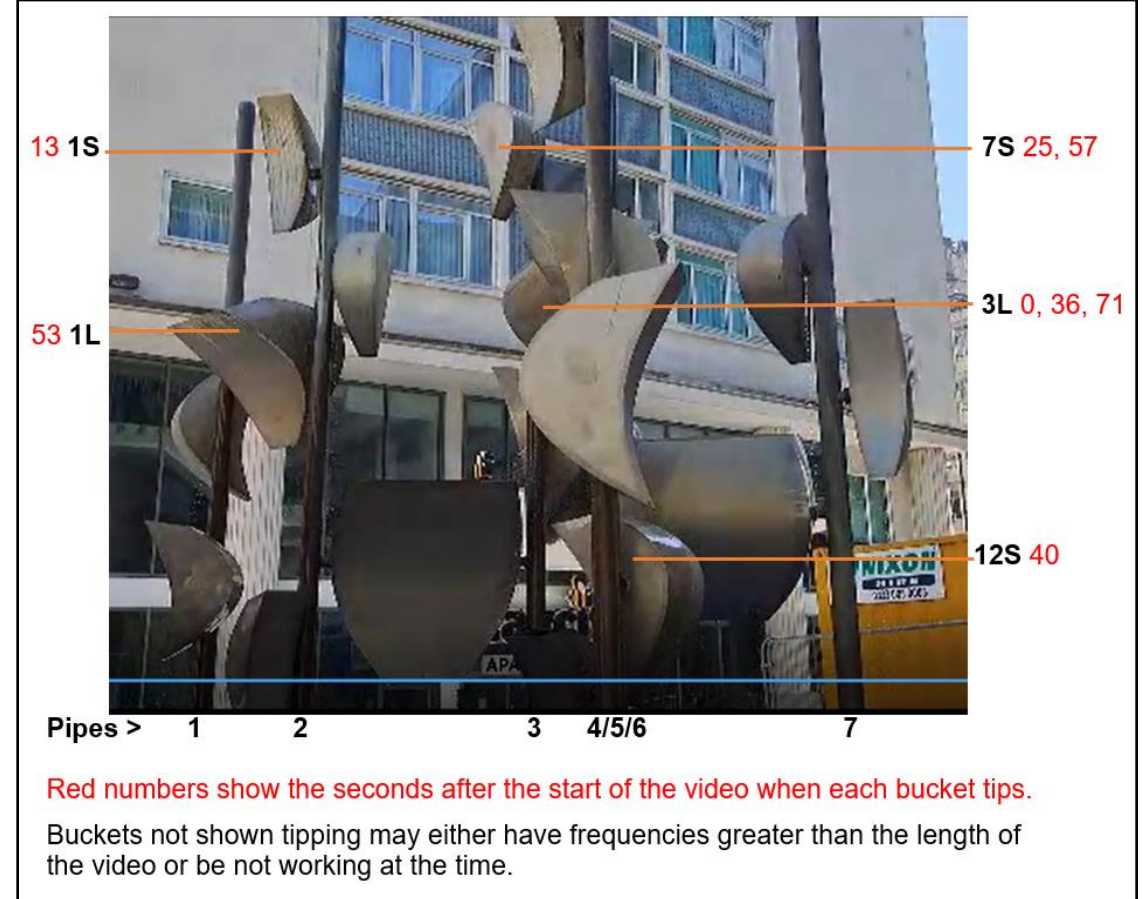
Friends of PF video of June 2023 - Duration 71 seconds

- Number of buckets shown tipping – 5 of 20
- Cascades shown - 8
- Number of times 2 or more buckets tip together - 0
- Shortest tipping frequency of a bucket - 32 seconds

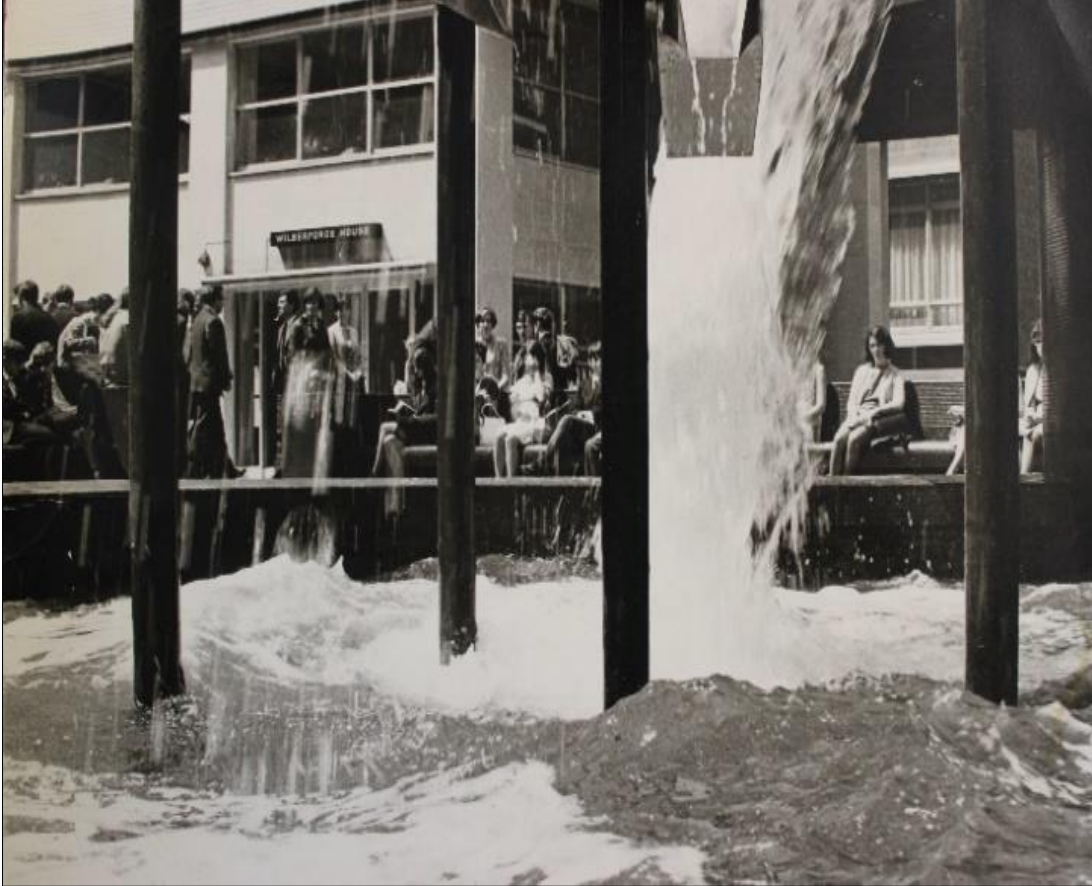
Original appearance with 420mm of water, 1967

"Creates a dramatic visual and acoustic display by replicating the sounds and movements of a stormy and tempestuous sea, ..." Official List Entry

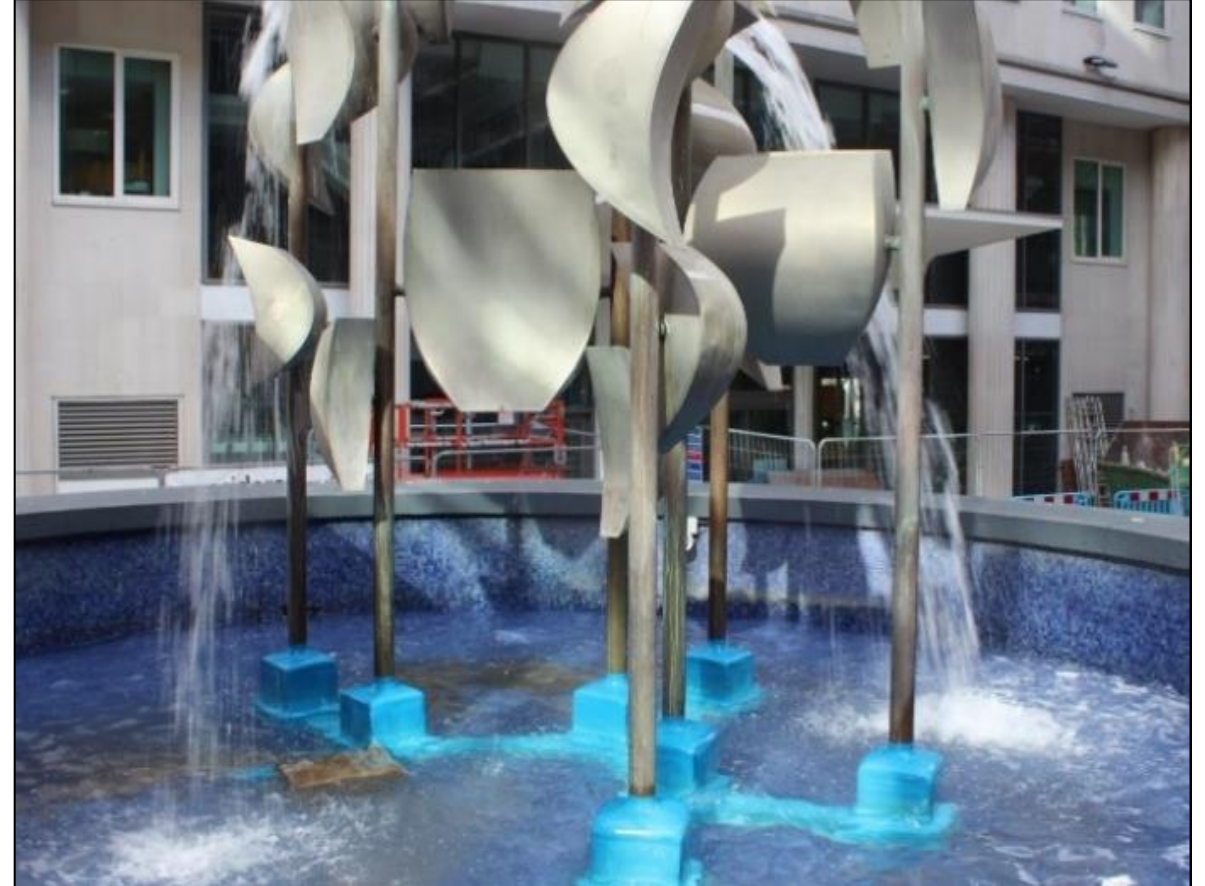
Appearance with 100mm of water

This "... particularly apt symbolism in the international port city of Liverpool" is currently non-existent

Restoration will fulfil this reason for listing by restoring the 420mm water depth and the consequent wave movements and sounds

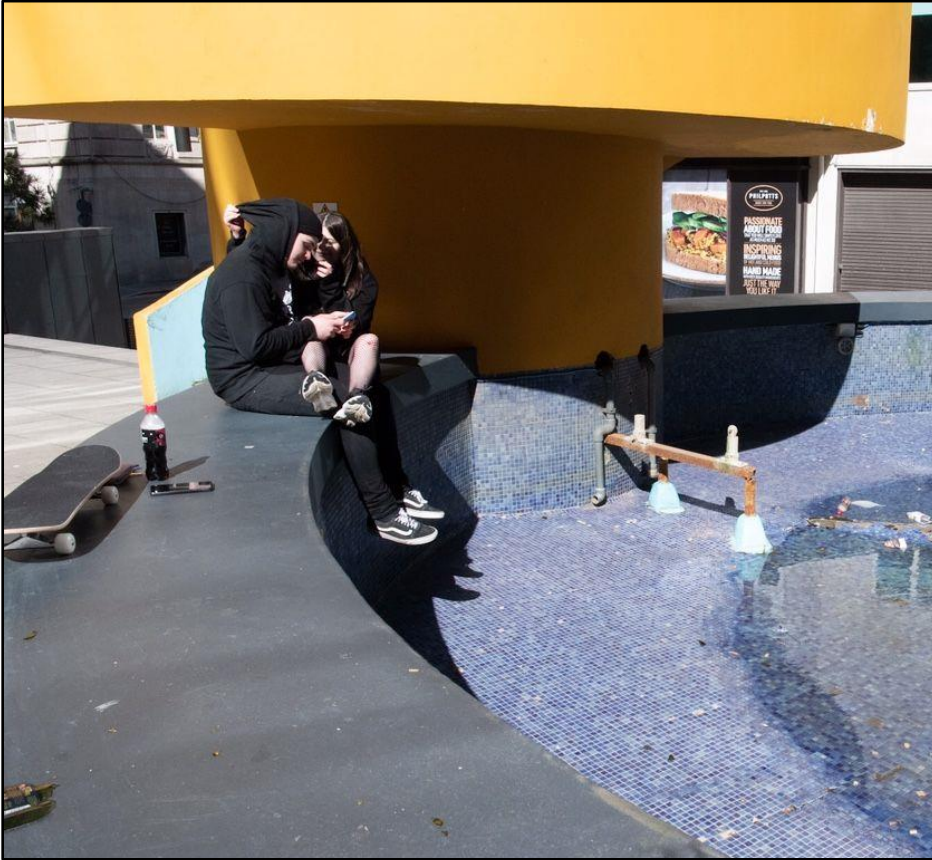
Current wide flat coping on low pool wall

Encourages children to climb onto, sit and stand on rim - increases risk of small children falling into new deeper water and invites others to paddle in pool.

Water depth above 100mm not considered safe.

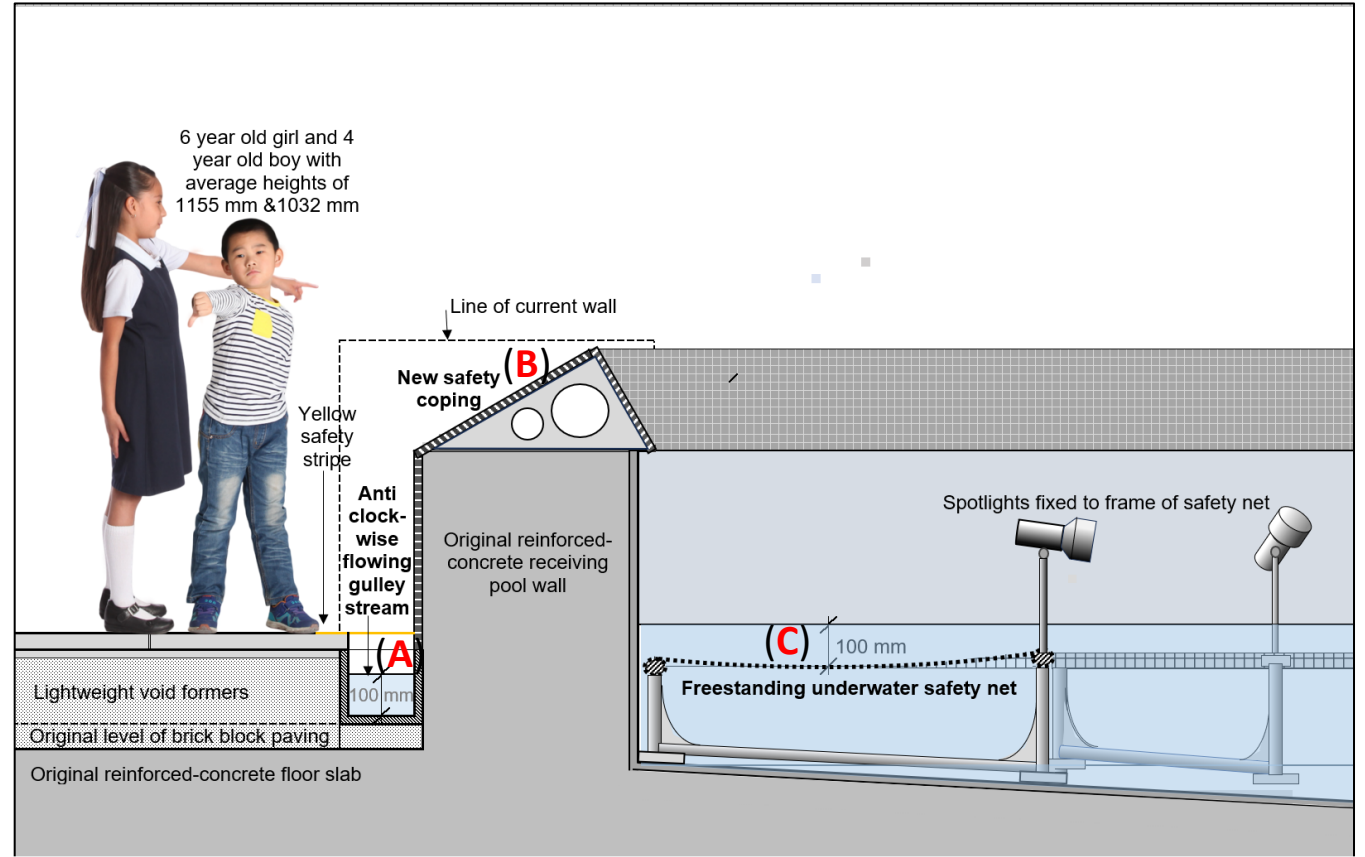
Three possible safety measures

- A) Restore original thinner wall width & form shallow stream around base**
Provides barrier & distracting safe water feature for small children
- B) Replace flat coping with triangular safety coping**
Stops people from sitting, standing or walking on rim of pool
- C) Install a freestanding underwater safety net**
Catches small children still falling in & prevents paddling in pool

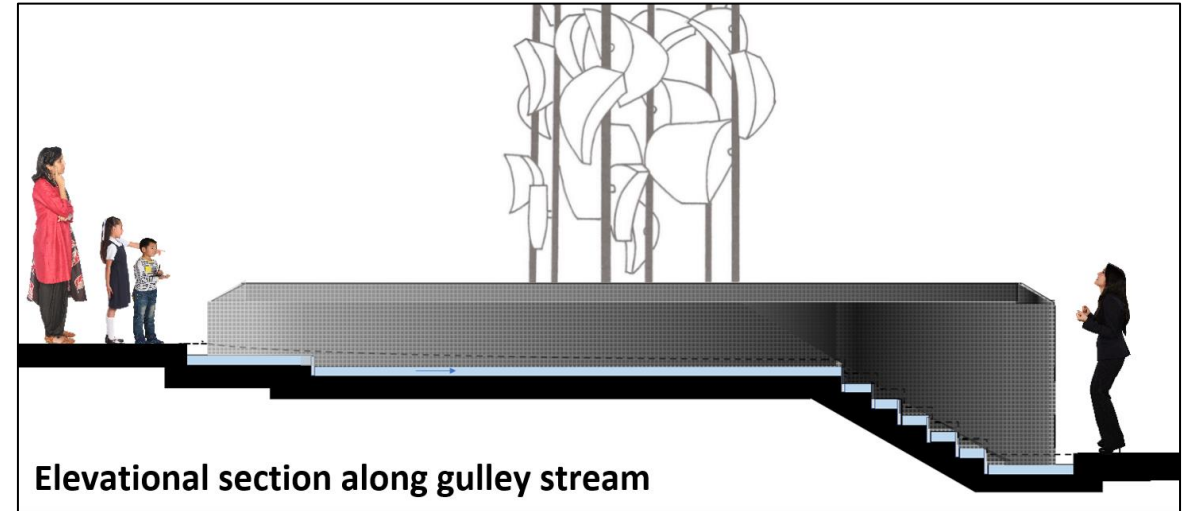
Elevational section along gulley stream

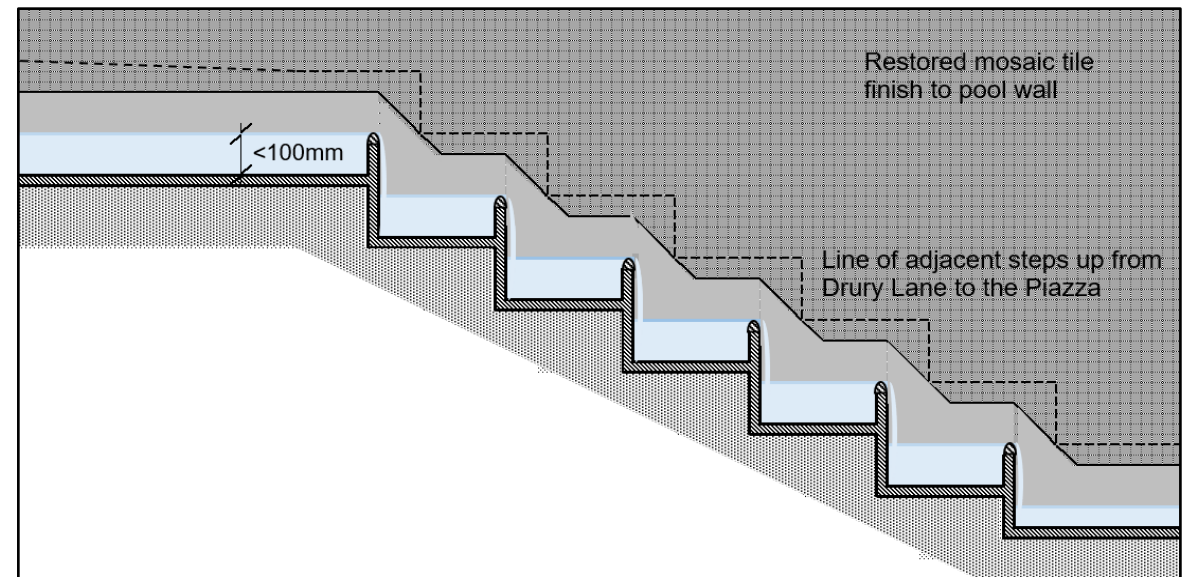
Section through cascades alongside steps from Drury Lane

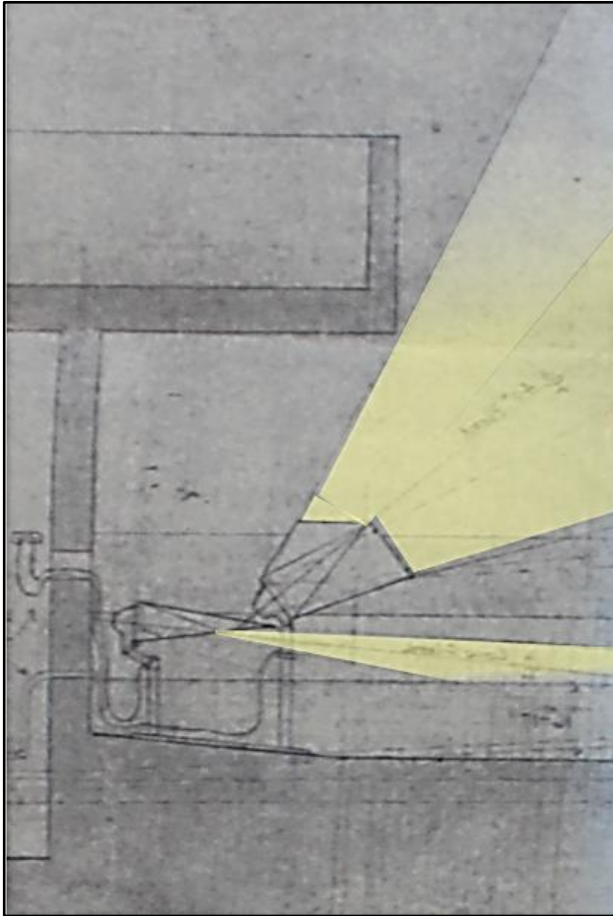
Design of original 2 floodlights

freestanding in receiving pool

Broad 40 deg upward floodlight
focussed on buckets/cascades

Narrow downfacing floodlight
focussed on waves in pool

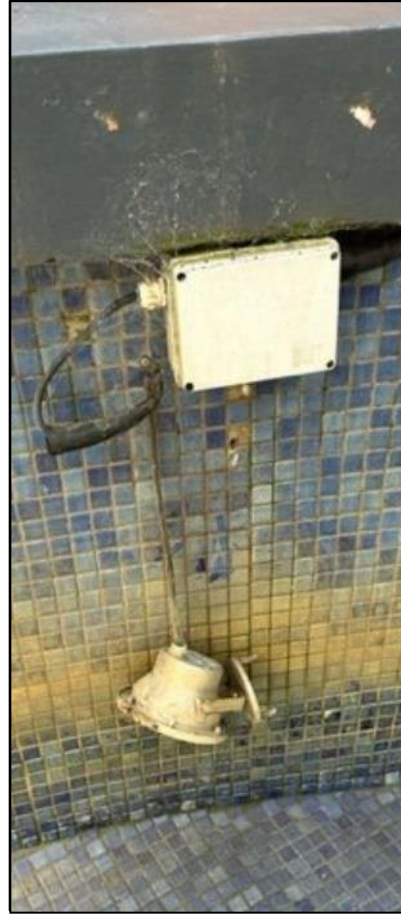
Current spotlights

fixed to pool wall

(Shown torn off, but
recently repaired)

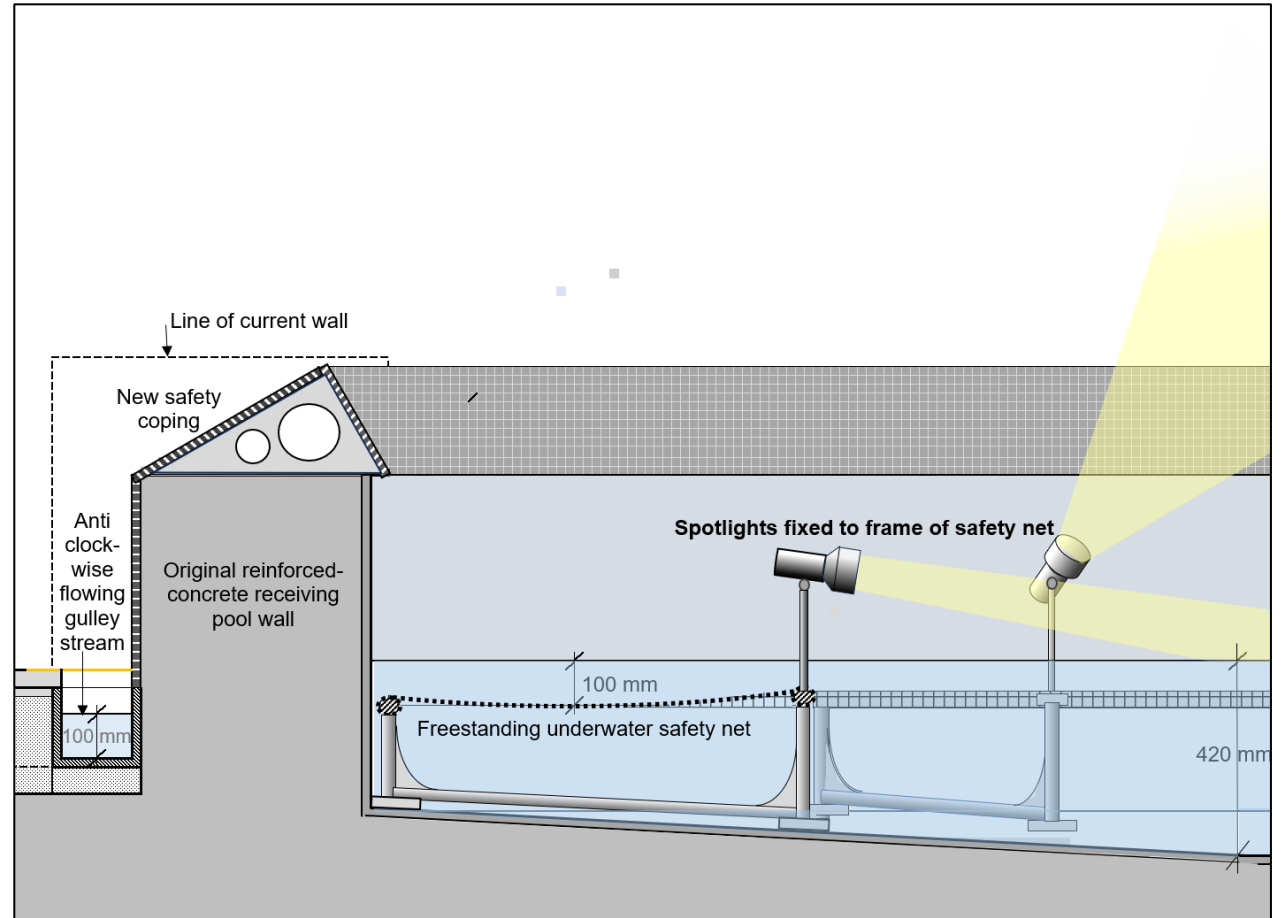
Six new spotlights on freestanding frame of safety net

Nearer to buckets and no longer in easy reach of vandals

Waterproof spotlights alternately focussed on buckets/cascades &
resulting waves in the receiving pool

Wiring for spotlights fully concealed in tubular framework of safety net

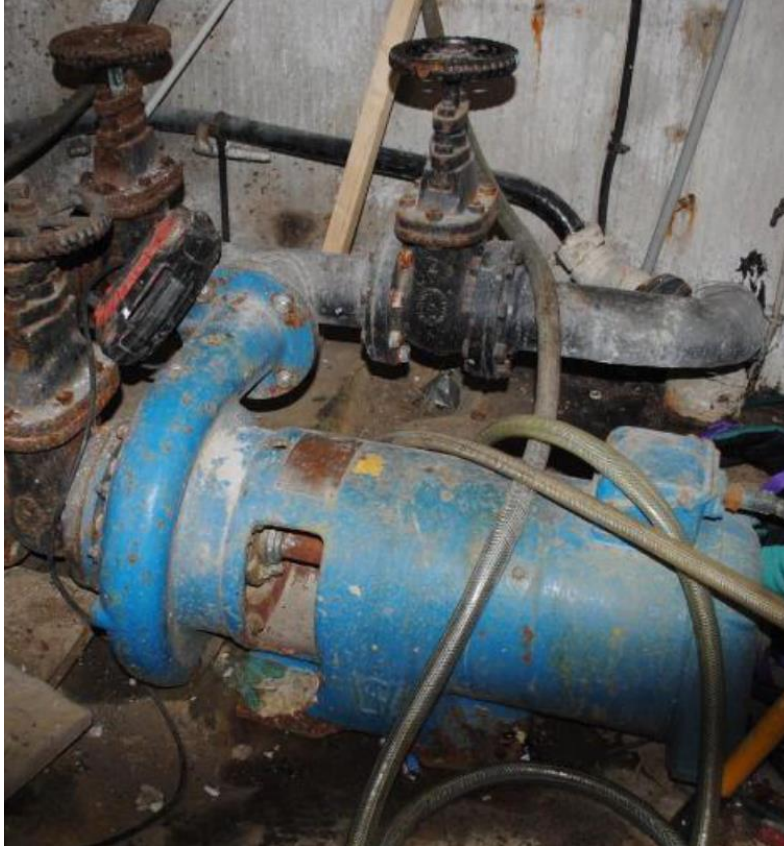
Original Main 3-Phase 17.5hp Pump

Replace original fountain pump with a:-
1. Modern main pump of comparable capacity but significantly more efficient, &
2. Smaller auxiliary twin impeller centrifugal pump circulating the gully streams

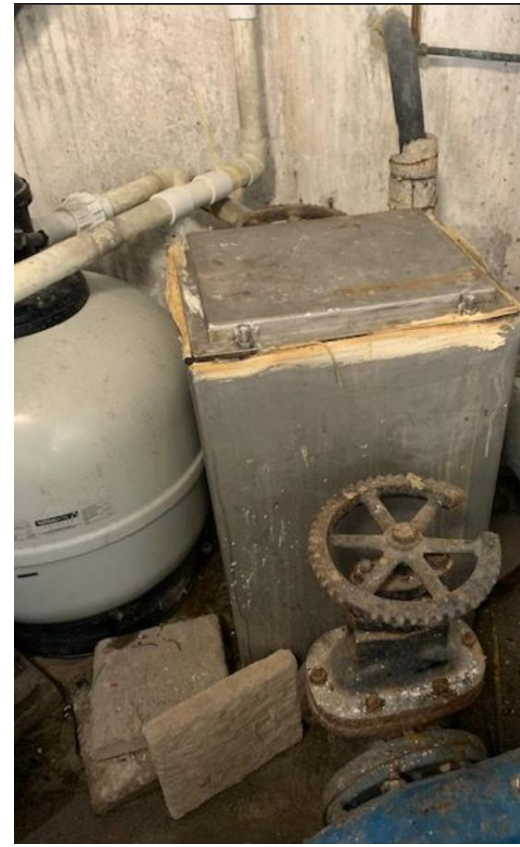
New and Old Sand Filters

Replace current filters with:-
1. inline heavy & fine particulate stainless-steel filters,
2. UV treatment system, and
3. Automatic chemical dosing

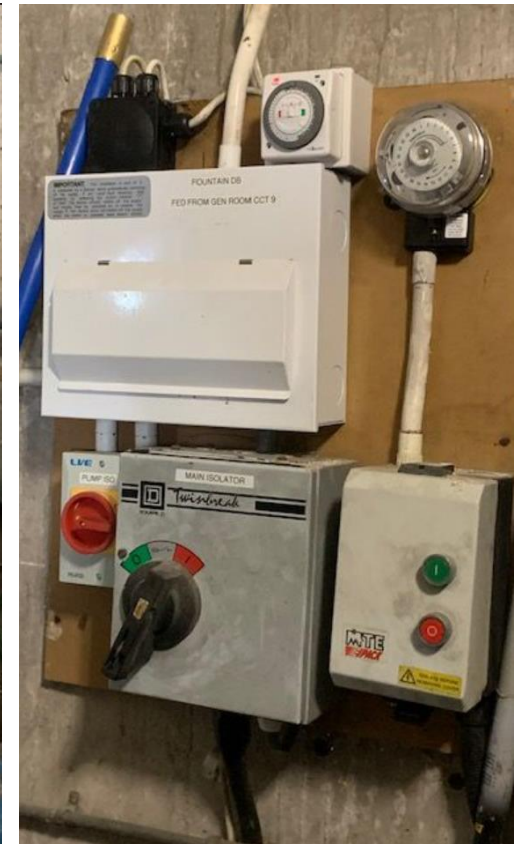
Current Electrical System

Replace and update electrical control system as necessary

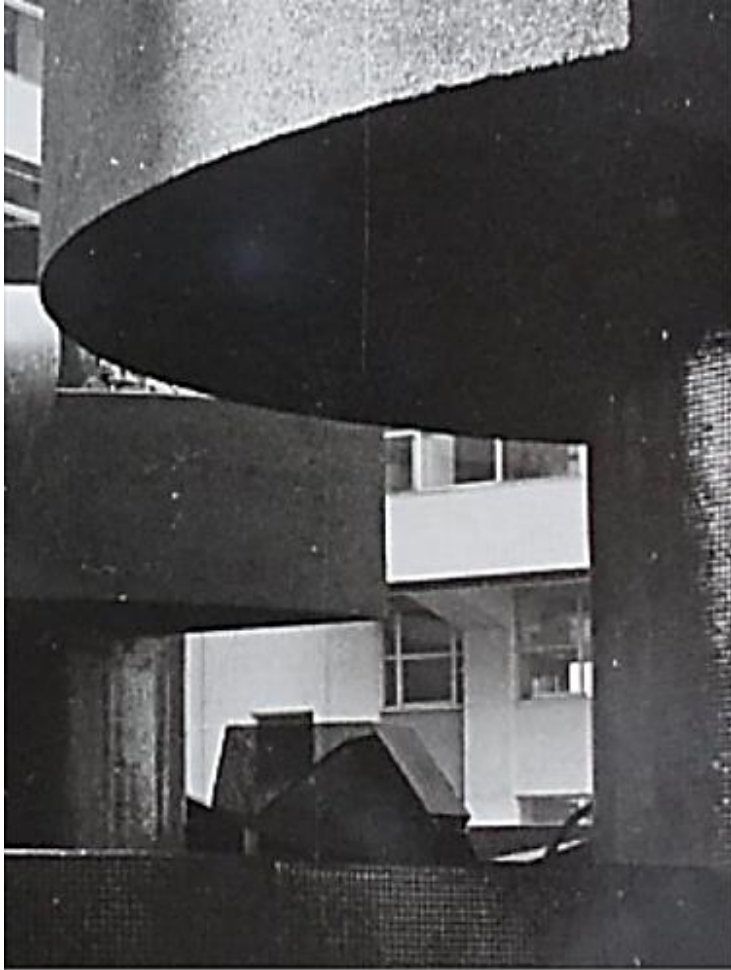
Original finishes of pool & platform walls

Richard Huws chose dark finishes to highlight the white cascades
