Restoration of the Piazza Fountain, Liverpool

- Richard Huws' sole surviving fountain
- Earliest & finest of only 2 'bucket' fountain in the World
- One of Historic England's "*most fascinating*" listings

Merseyside Civic Society

2: Restoration of the Piazza Fountain, Drury Lane, Liverpool

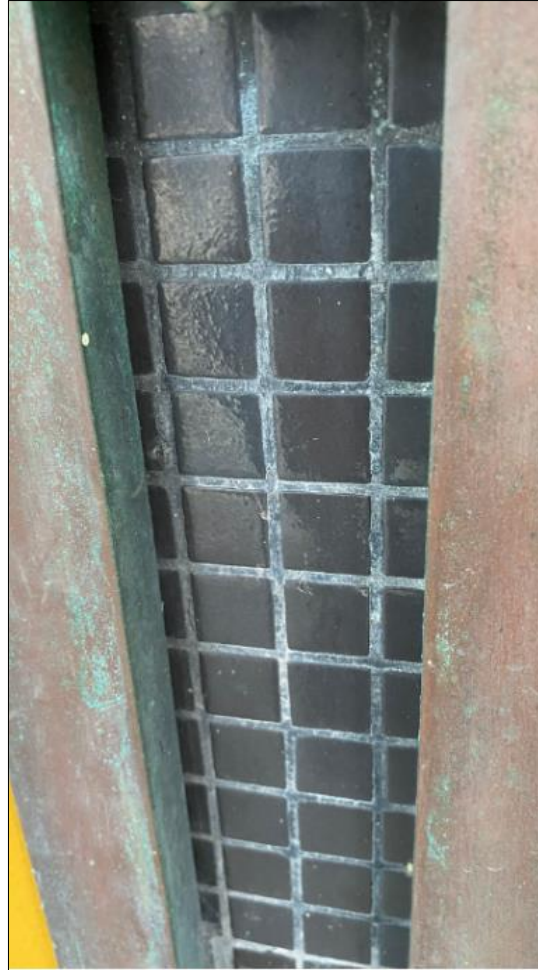
**Surviving area of original
black ceramic mosaic tiles**

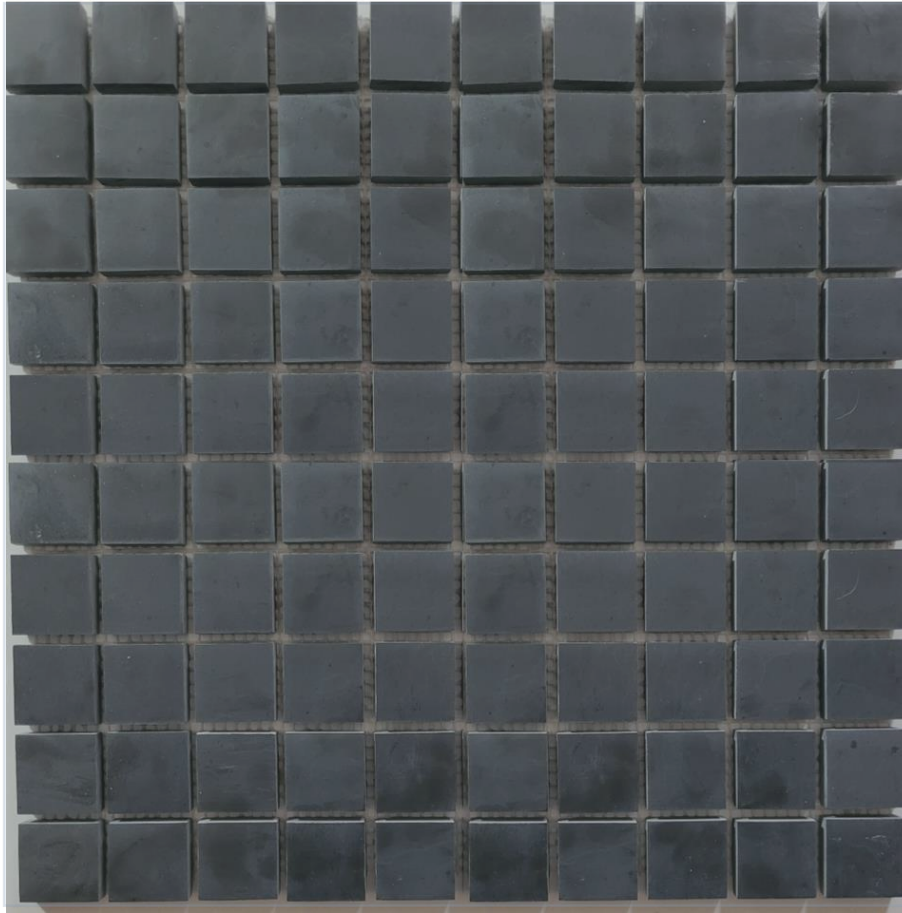
Proposed use of Cwt-y-Bugail dark blue grey polished Welsh slate mosaic 'tiles'
(300 mm x 300mm sheet prior to grouting)

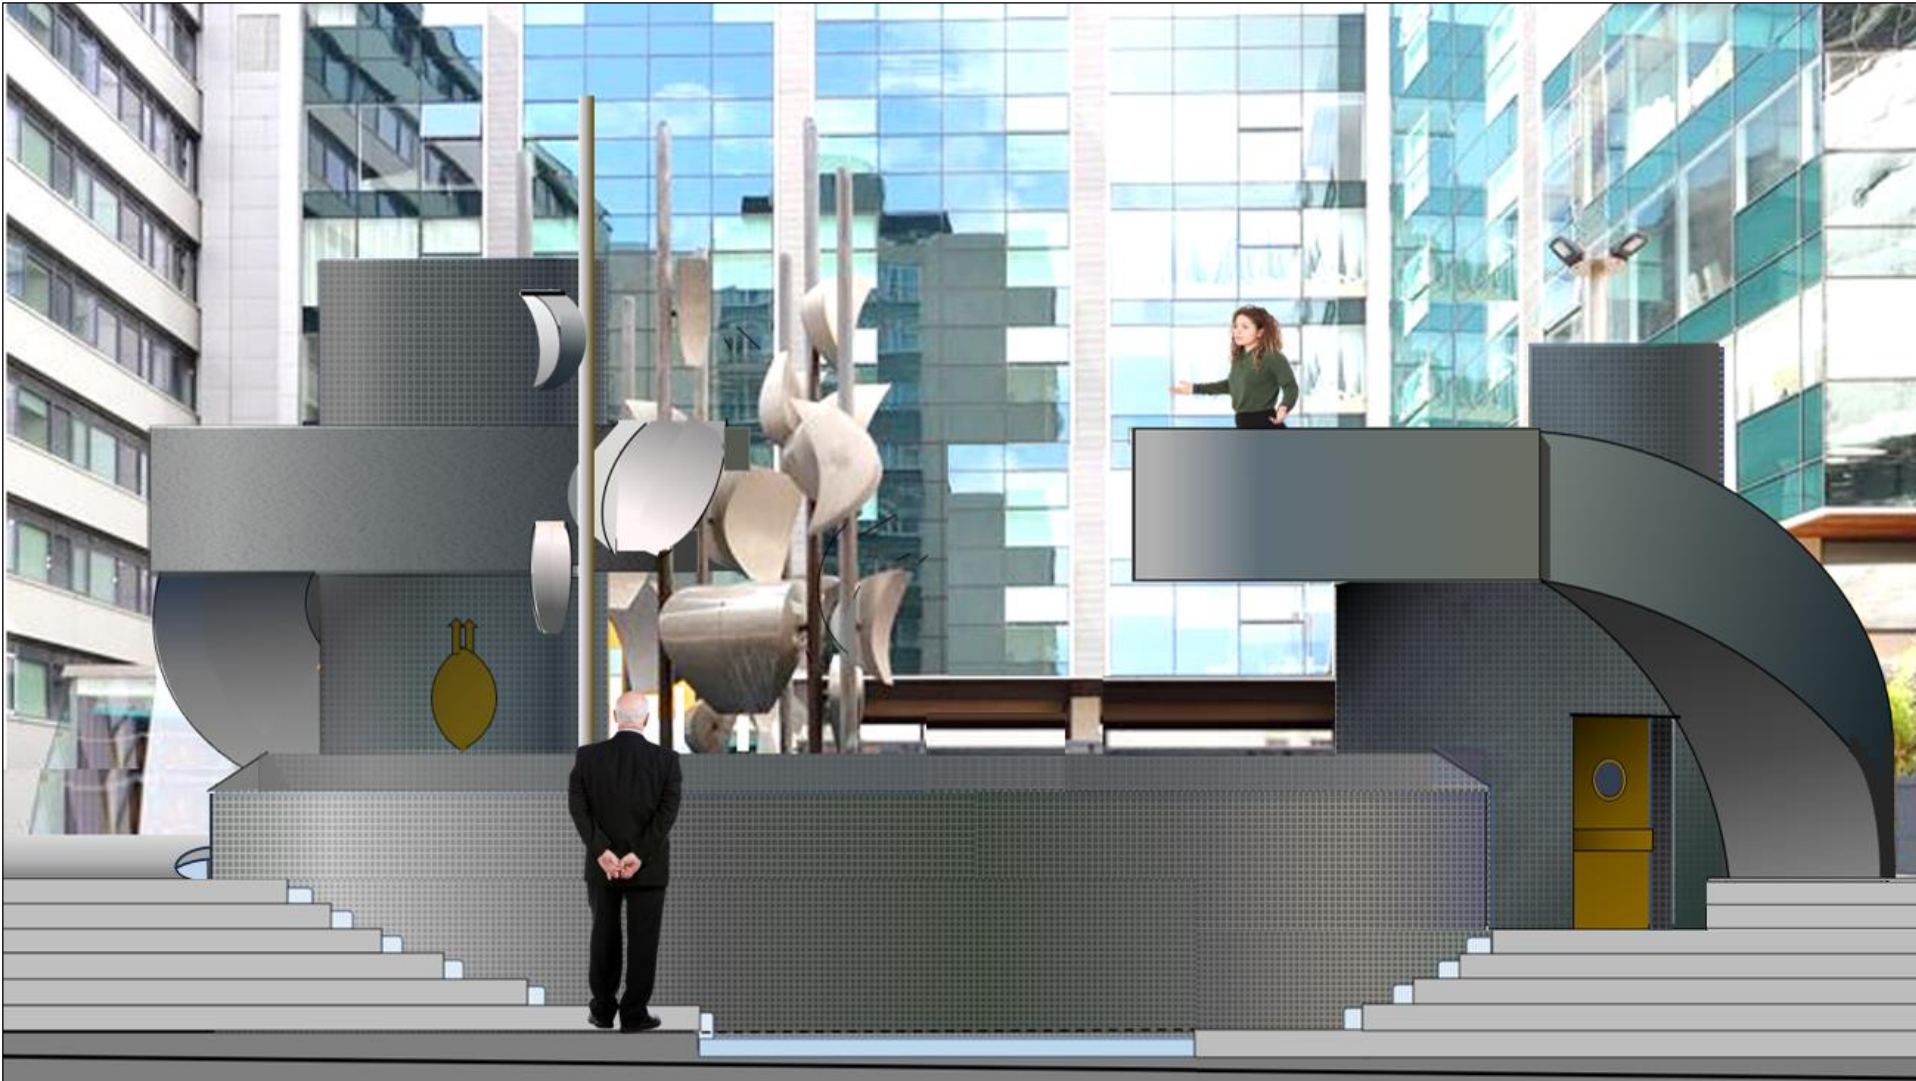
**Piazza Fountain
Elevation to
Drury Lane**

Use of Cwt-y-Bugail dark blue grey Welsh slate tiling and matching paint

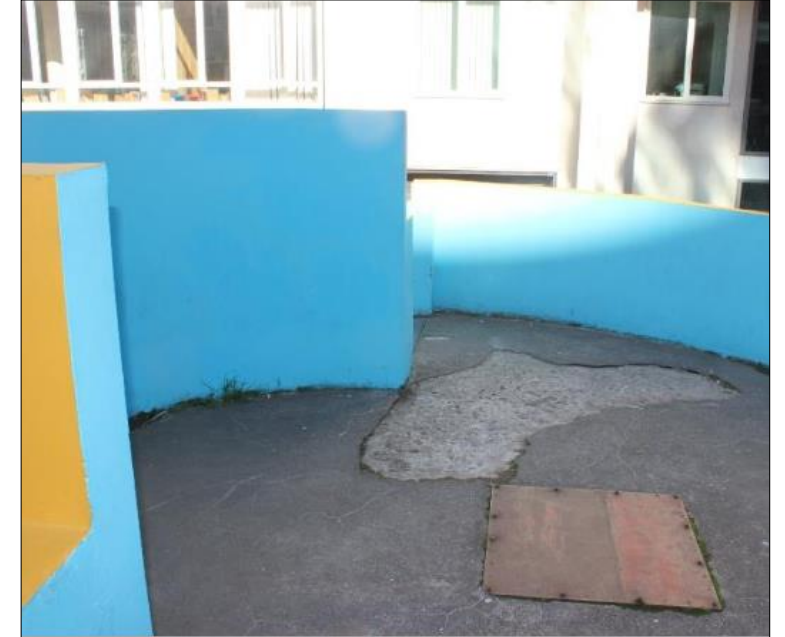
Current disintegrating asphalt floor
finish to viewing platforms

Asphalt to be replaced with original
red brindle brick tiling

Steel covered pavement light to pump
room to be also restored

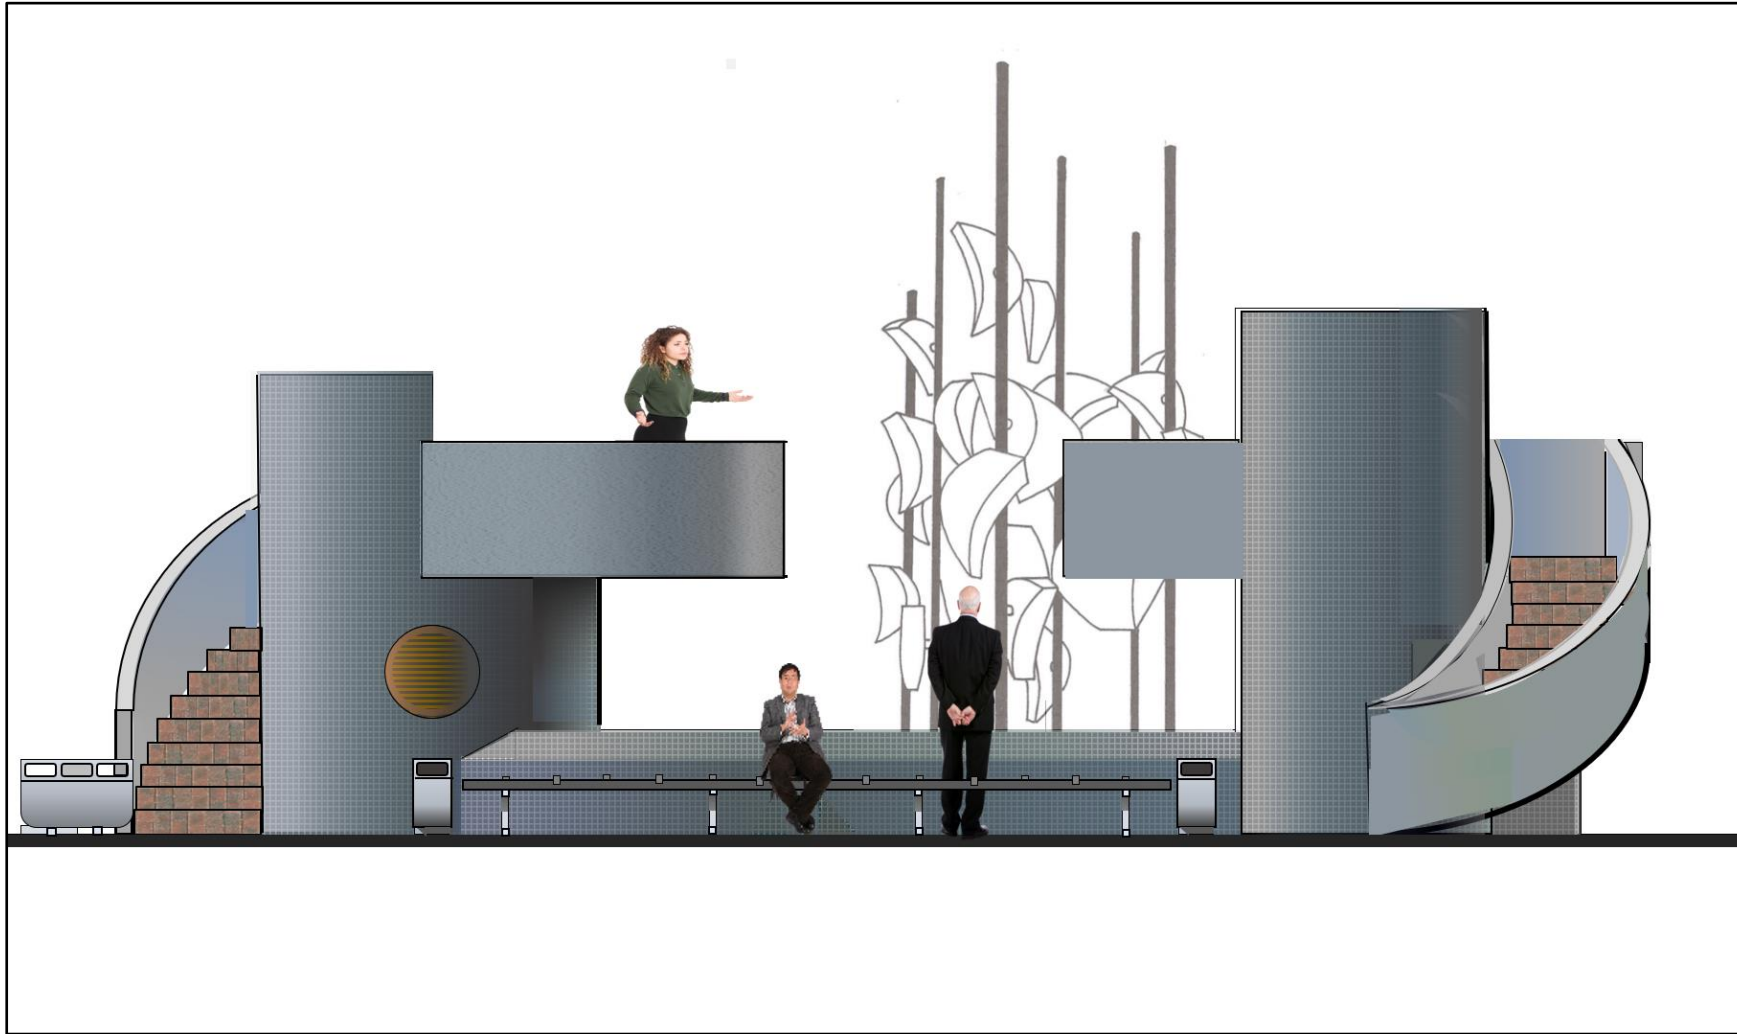
Piazza Fountain, Elevation to the Piazza showing restored stair finish
(and proposed reinstated seating, litter bins and bronze restoration plaque)
